Building Badbury Park Estate

Survey Start Time today, 03/12/2025 at 18:50

By Rachel Harling

1.1 Play Area behind Ashcombe close

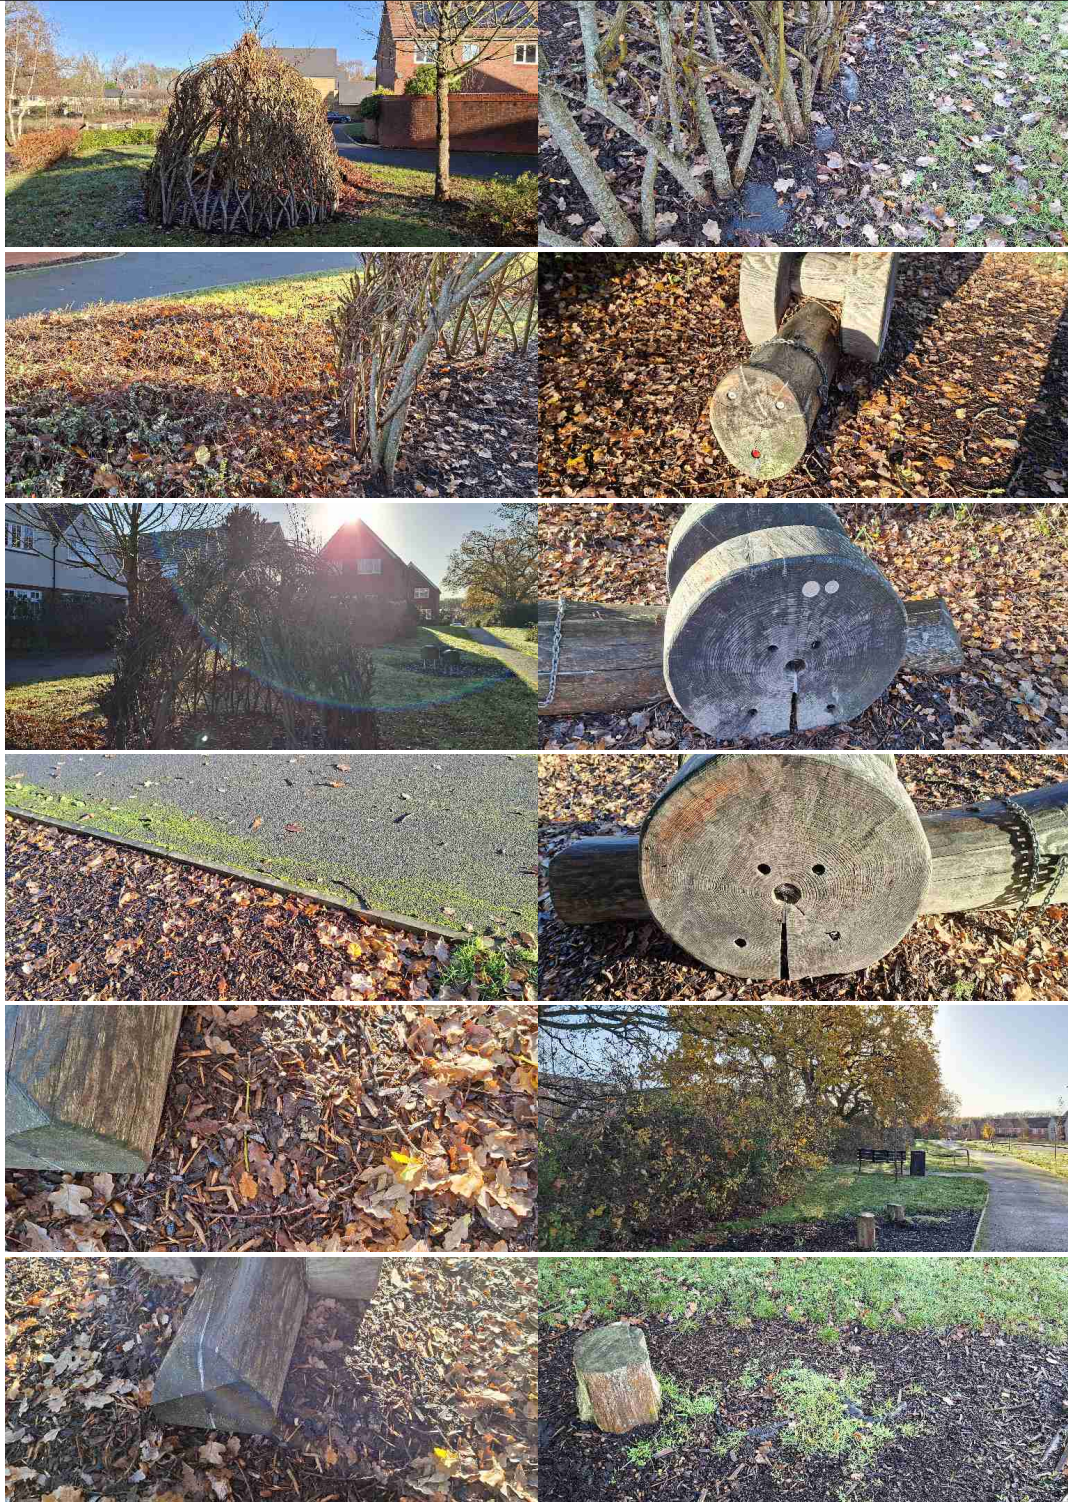
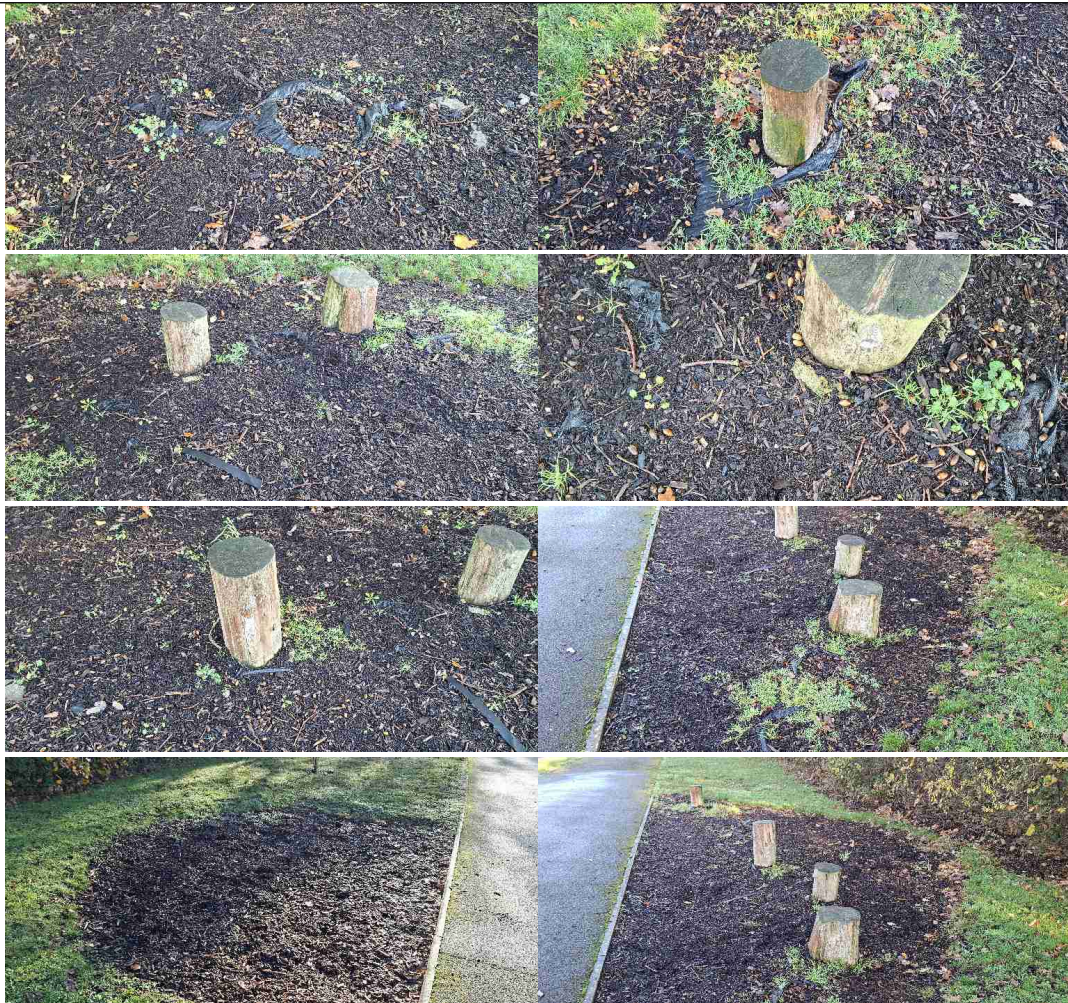
Task:	Question - Badbury Park Estate [7233899]	Process:	Informal
Status:	InProgress	Category:	
Audience:	Private	Assignee:	Remus / CDF Rachel Harling
Target Completion Date:		Next Action Date:	10/12/2025
Importance:	High	Subject:	Ashcombe - Play Area
Description:	<p>Sheep - metal feet and concrete stands visible. Needs topping up with play area mulch to level out and cover these areas</p> <p>Snail - Mulch needs topping up to level out as base is starting to show as well as wooden strip edges</p> <p>Wooden stepping stones - remaining ones are rotting and loose and need removal. Liner is also showing and whole area needs topping up to level while</p>

alternative to steps is sought

Willow T-Pee - mulch needs topping up as liner on display after cut-back

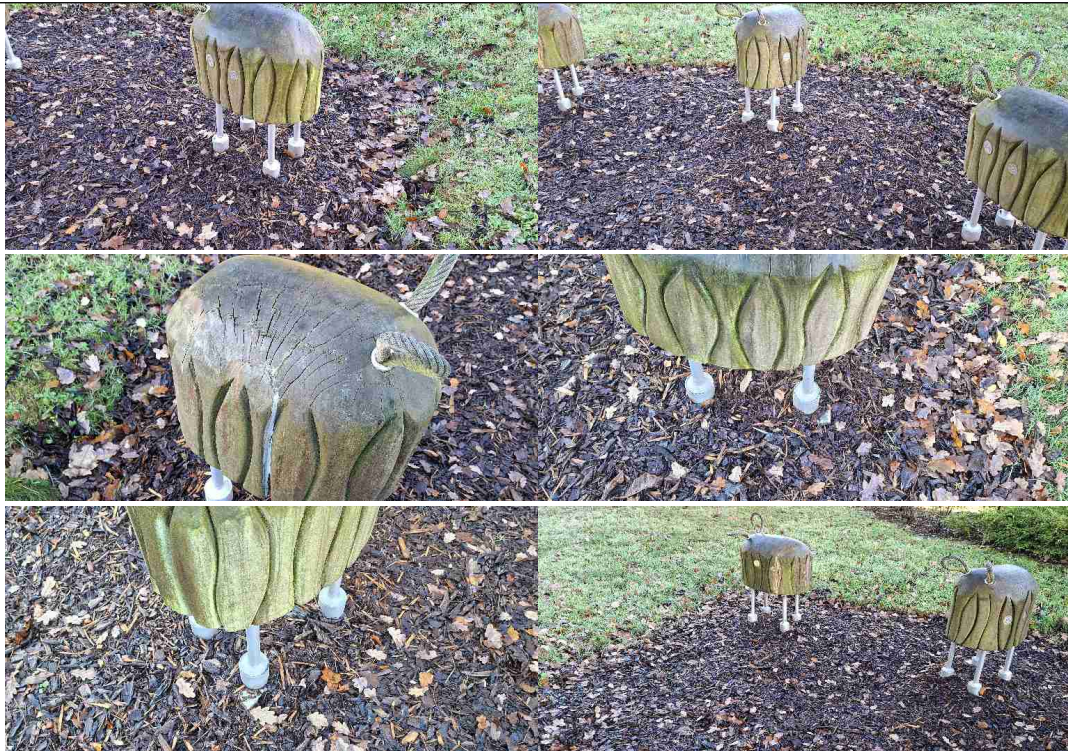
Task:	Question - Badbury Park Estate [7233900]	Process:	Informal
Status:	InProgress	Category:	
Audience:	Private	Assignee:	Remus / CDF Rachel Harling
Target Completion Date:		Next Action Date:	10/12/2025
Importance:	High	Subject:	Ashcombe Play Area - additional photos
Description:	See photos...

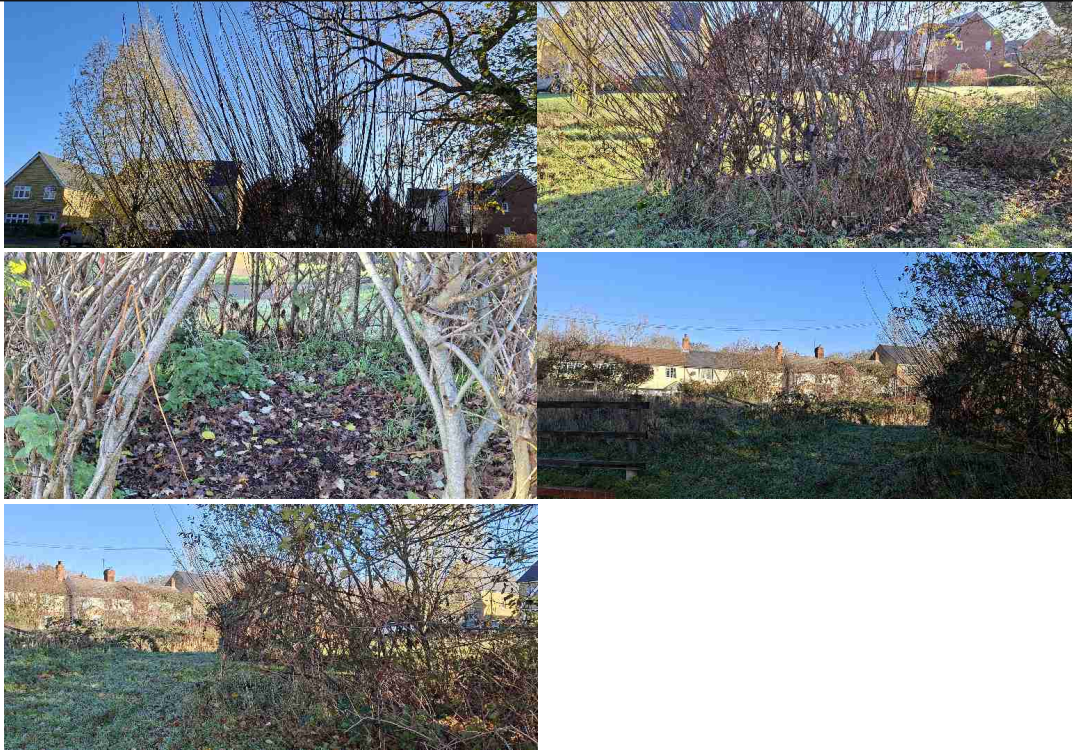
Task:	Question - Badbury Park Estate [7233901]	Process:	Informal
Status:	InProgress	Category:	
Audience:	Private	Assignee:	Remus / CDF Rachel Harling
Target Completion Date:		Next Action Date:	10/12/2025
Importance:	High	Subject:	Iford Close - Willow T-pee
Description:	Needs access cleared from path, weeds and nettles removed from inside and around edges and willow cut back so shape is reformed

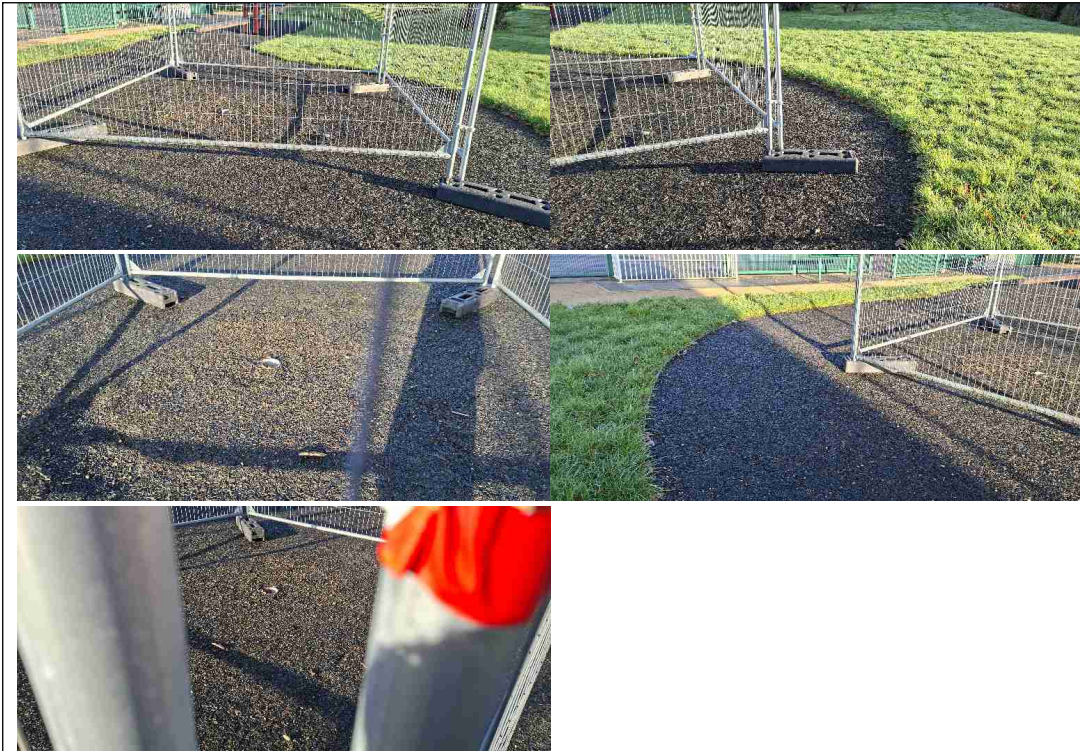
Task:	Question - Badbury Park Estate [7233903]	Process:	Informal
Status:	InProgress	Category:	
Audience:	Private	Assignee:	Remus / CDF Rachel Harling
Target Completion Date:		Next Action Date:	10/12/2025
Importance:	High	Subject:	Metal insert from Carousel needs removal and hole filled - Homington Play Area
Description:	<p>This insert needs to be removed, hole filled (with hard wearing soft substance to negate accidents), levelled and flush with matting.</p> <p>Once complete, HERAS fence can be removed</p>		
Images:

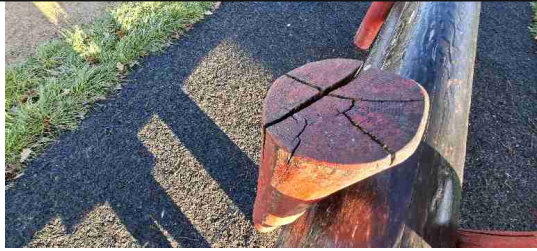
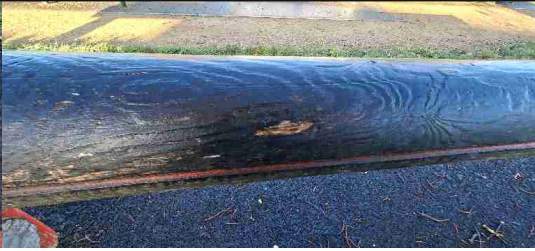
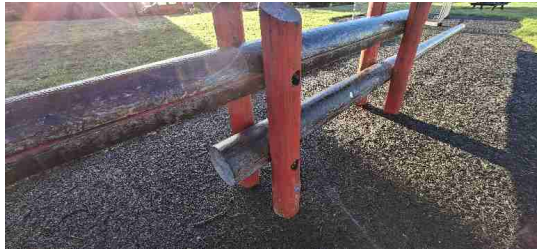
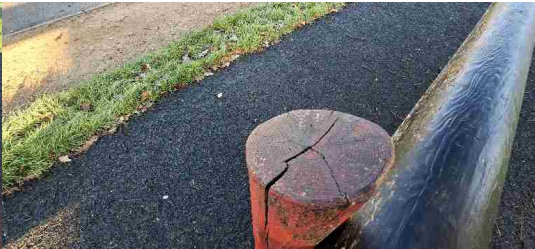
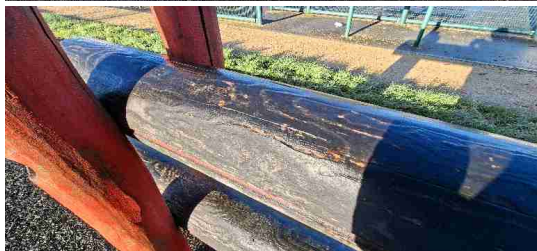
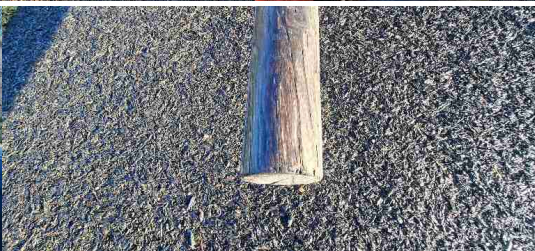
Task:	Question - Badbury Park Estate [7233905]	Process:	Informal
Status:	InProgress	Category:	
Audience:	Private	Assignee:	Remus / CDF Rachel Harling
Target Completion Date:		Next Action Date:	10/12/2025
Importance:	High	Subject:	Balancing Pole - Homington Play Area
Description:	Some chipped rough edges that need to be sanded down		
Images:

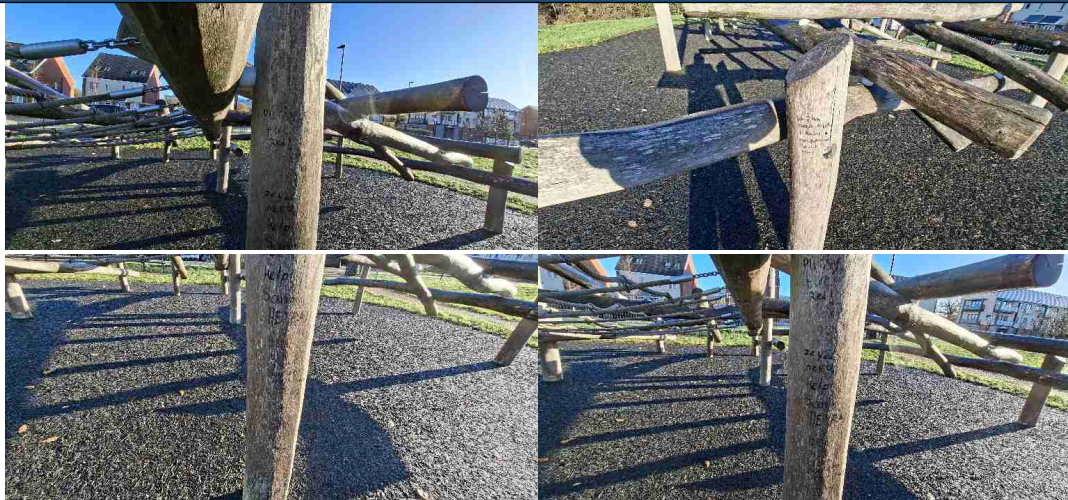
Task:	Question - Badbury Park Estate [7233906]	Process:	Informal
Status:	InProgress	Category:	
Audience:	Private	Assignee:	Remus / CDF Rachel Harling
Target Completion Date:		Next Action Date:	10/12/2025
Importance:	High	Subject:	Climber - Homington Ave Play Area
Description:	Graffiti to be sanded off

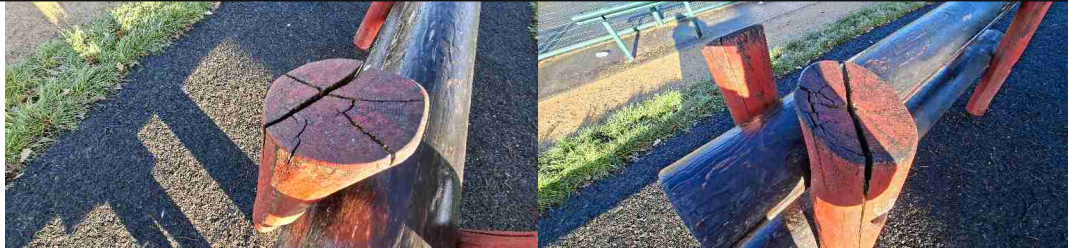
Task:	Question - Badbury Park Estate [7233908]	Process:	Informal
Status:	InProgress	Category:	
Audience:	Private	Assignee:	Remus / CDF Rachel Harling
Target Completion Date:		Next Action Date:	10/12/2025
Importance:	High	Subject:	Balancing Beam - Homington Play Area
Description:	Some areas that may be finger traps, will have filled		
Images:

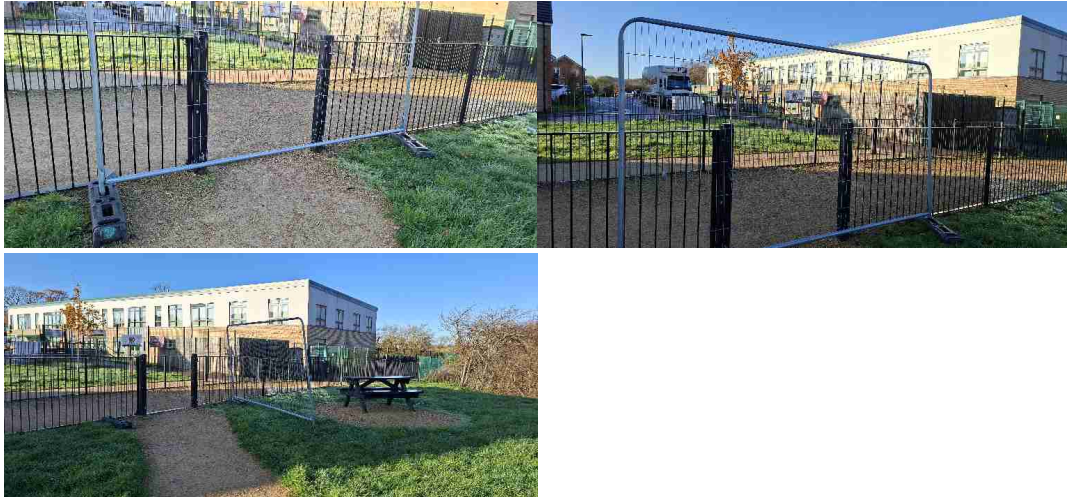
- Missing gate is going to be replaced with fencing. Once completed, HERAS fence can be removed

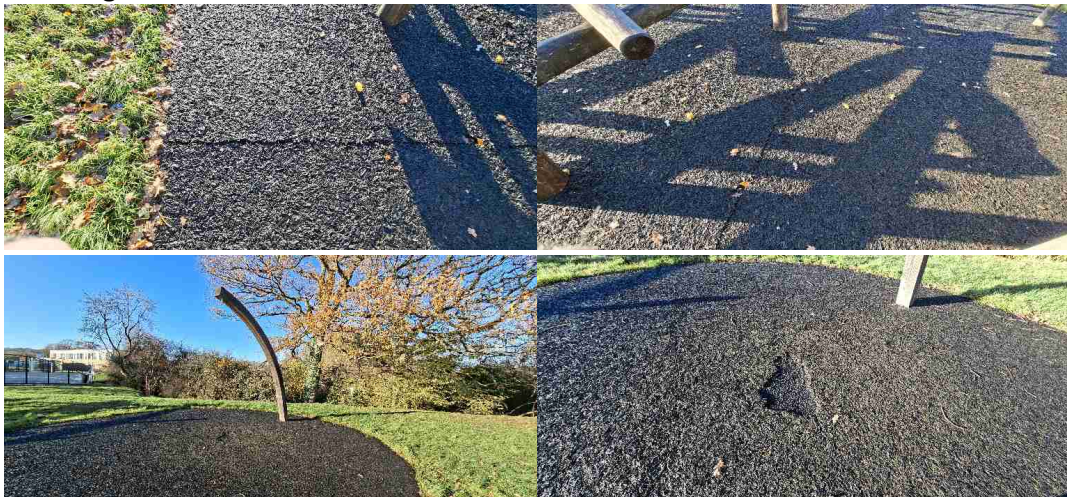
- Slight tear and wear patch but does not require replacement at this stage. Will monitor for any further degradation

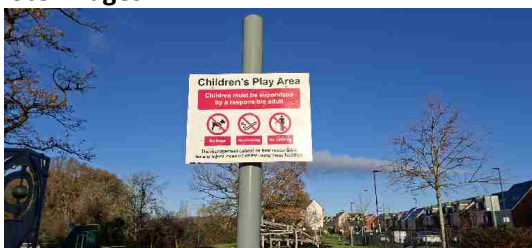
- Ground in general is uneven from wear & tear. Unable to locate any obvious trip hazards but will monitor for any degradation

- See photos...

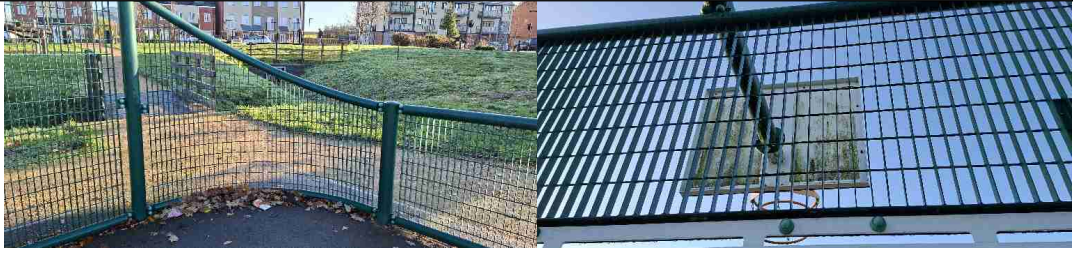
Task:	Question - Badbury Park Estate [7233911]	Process:	Informal
Status:	InProgress	Category:	
Audience:	Private	Assignee:	Remus / CDF Rachel Harling
Target Completion Date:		Next Action Date:	10/12/2025
Importance:	Medium	Subject:	MUGA - Homington Play Area
Description:	Cleanliness - algae, moss, dirt etc to fencing, hoops, goals and flooring. Whole area needs a pressure wash.		
Images:

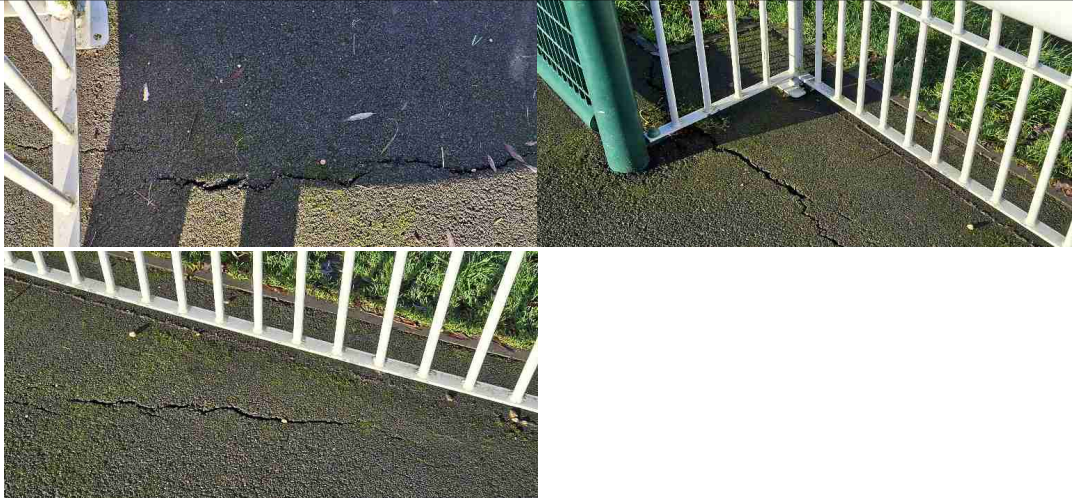
Task:	Question - Badbury Park Estate [7233912]	Process:	Informal
Status:	InProgress	Category:	
Audience:	Private	Assignee:	Remus / CDF Rachel Harling
Target Completion Date:		Next Action Date:	10/12/2025
Importance:	High	Subject:	Damaged tarmac MUGA - Homington Play Area
Description:	Some splits in the tarmac that if left untreated could get worse - i.e. finger entrapment or trip hazard		
Images:

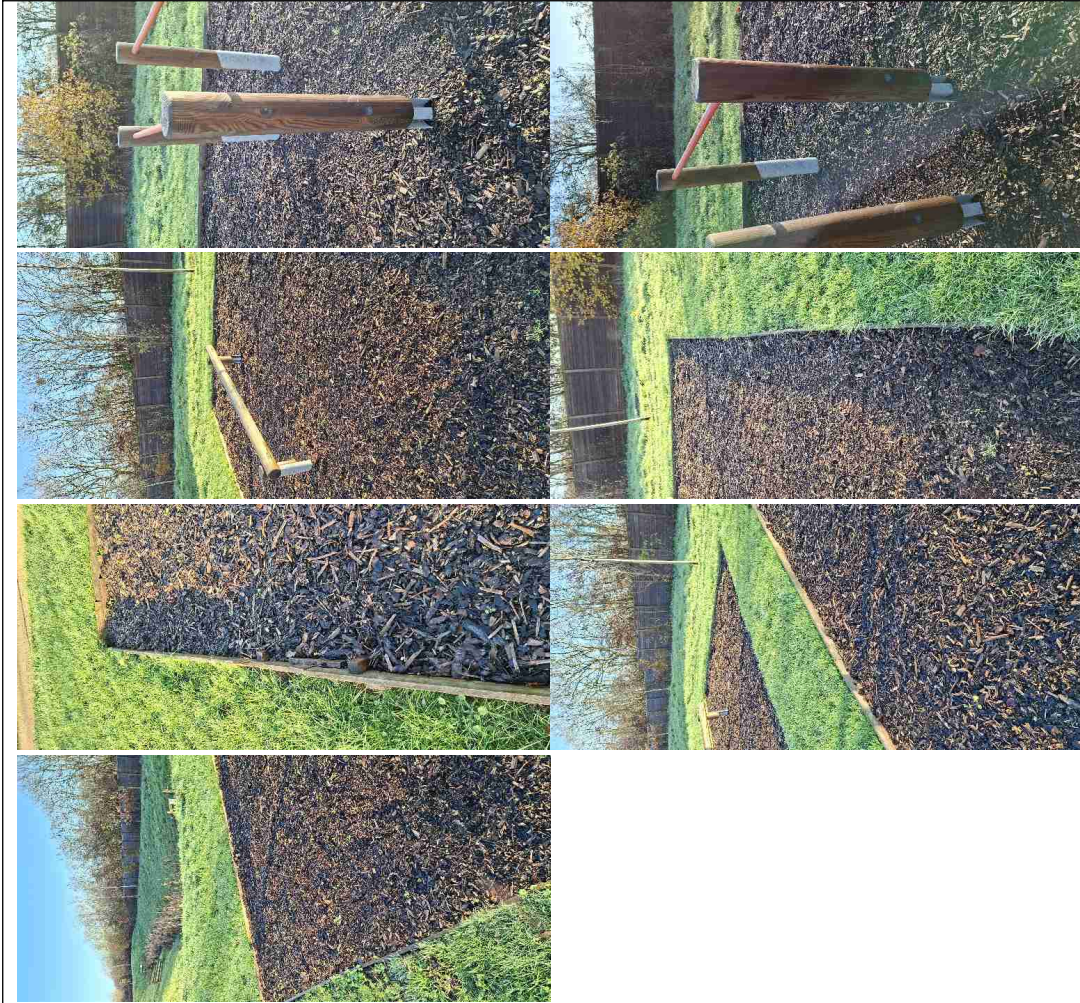
Task:	Question - Badbury Park Estate [7233913]	Process:	Informal
Status:	InProgress	Category:	
Audience:	Private	Assignee:	Remus / CDF Rachel Harling
Target Completion Date:		Next Action Date:	10/12/2025
Importance:	High	Subject:	Monthly visual inspections - Clitchbury play area
Description:	This will be included as part of the new landscaping contract		
Images:			
Task:	Question - Badbury Park Estate [7233914]	Process:	Informal
Status:	InProgress	Category:	
Audience:	Private	Assignee:	Remus / CDF Rachel Harling
Target Completion Date:		Next Action Date:	10/12/2025
Importance:	High	Subject:	Clitchbury Play Area - flooring
Description:	Mulch level is very low and needs to be topped up to be level with edging		
Images:

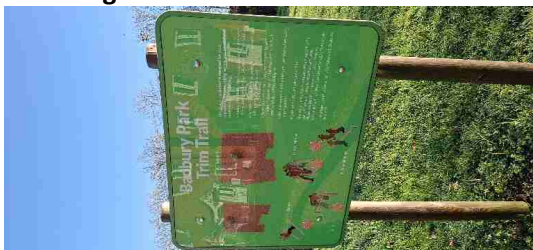
- See photos...

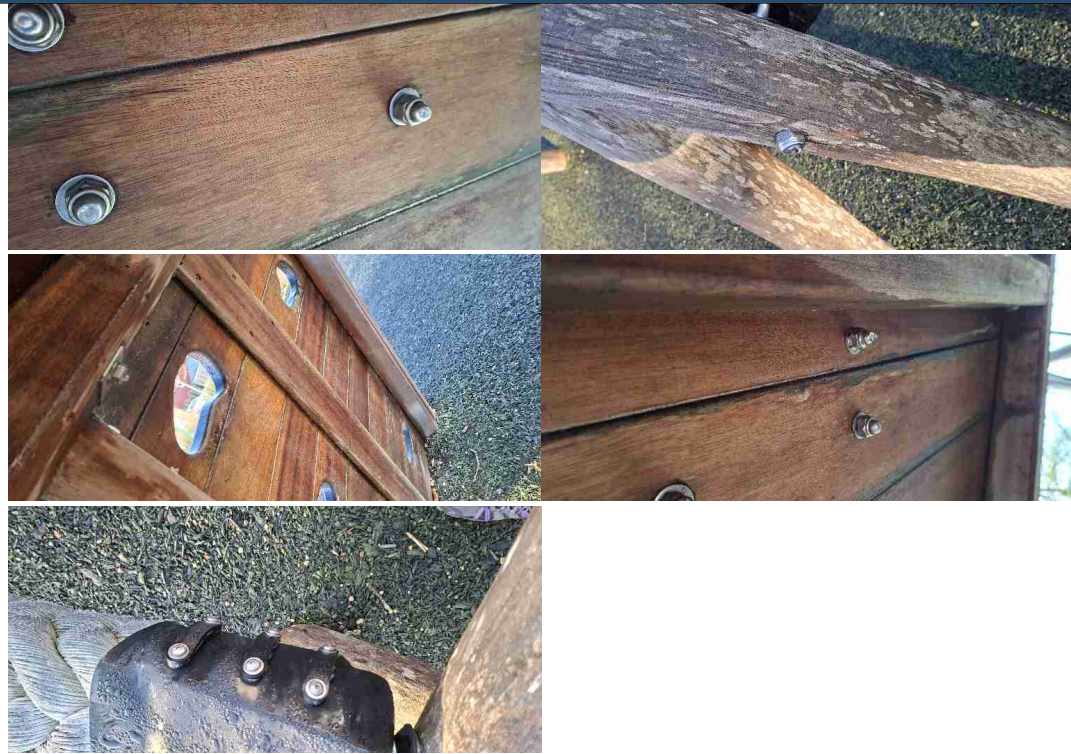
Task:	Question - Badbury Park Estate [7233915]	Process:	Informal
Status:	InProgress	Category:	
Audience:	Private	Assignee:	Remus / CDF Rachel Harling
Target Completion Date:		Next Action Date:	10/12/2025
Importance:	High	Subject:	Climber - Coatley Play Area
Description:	Some rough edges to be sanded down - needs to be checked all over as photos didn't save at time of this visit		
Images:			
Task:	Question - Badbury Park Estate [7233916]	Process:	Informal
Status:	InProgress	Category:	
Audience:	Private	Assignee:	Remus / CDF Rachel Harling
Target Completion Date:		Next Action Date:	10/12/2025
Importance:	High	Subject:	Climber - Coatley Play Area
Description:	Some caps missing and some exposed bolts to be levelled off

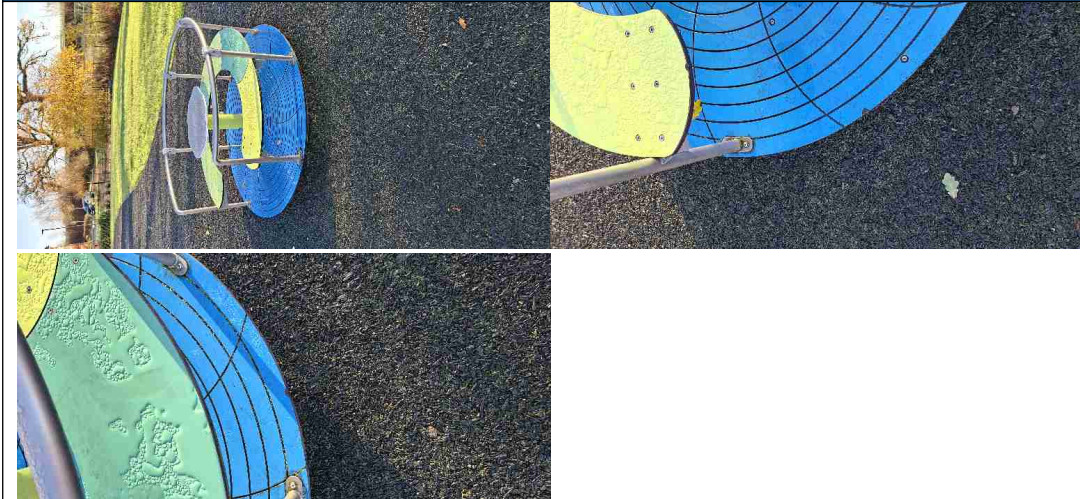
Task:	Question - Badbury Park Estate [7233918]	Process:	Informal
Status:	InProgress	Category:	
Audience:	Private	Assignee:	Remus / CDF Rachel Harling
Target Completion Date:		Next Action Date:	10/12/2025
Importance:	High	Subject:	Roundabout - Coatley Close
Description:	Some bolts are loose and need tightening Some chipped edges to be sanded down

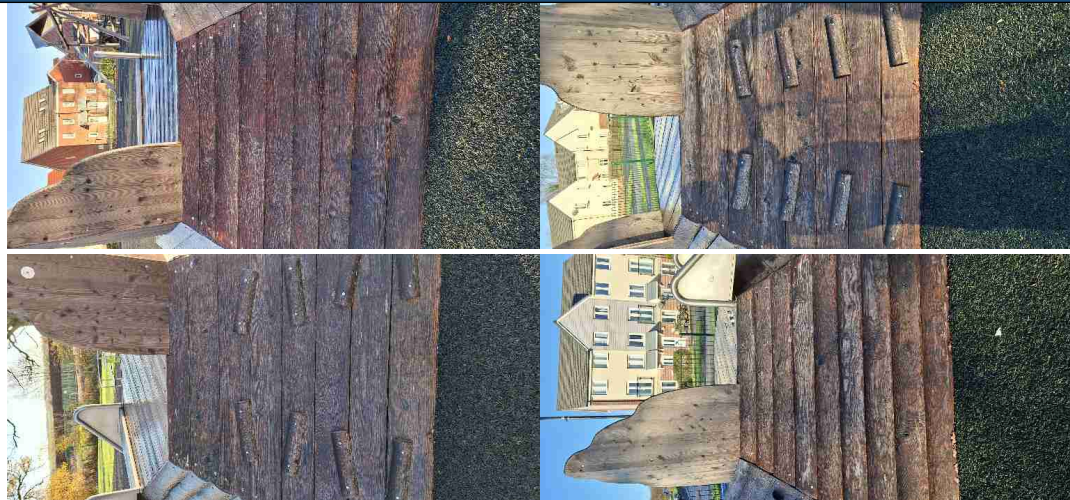
Status:	InProgress	Category:	
Audience:	Private	Assignee:	Remus / CDF Rachel Harling
Target Completion Date:		Next Action Date:	10/12/2025
Importance:	High	Subject:	Small Climber - Coatley Play Area
Description:	Needs to be checked fully all over and any gaps filled

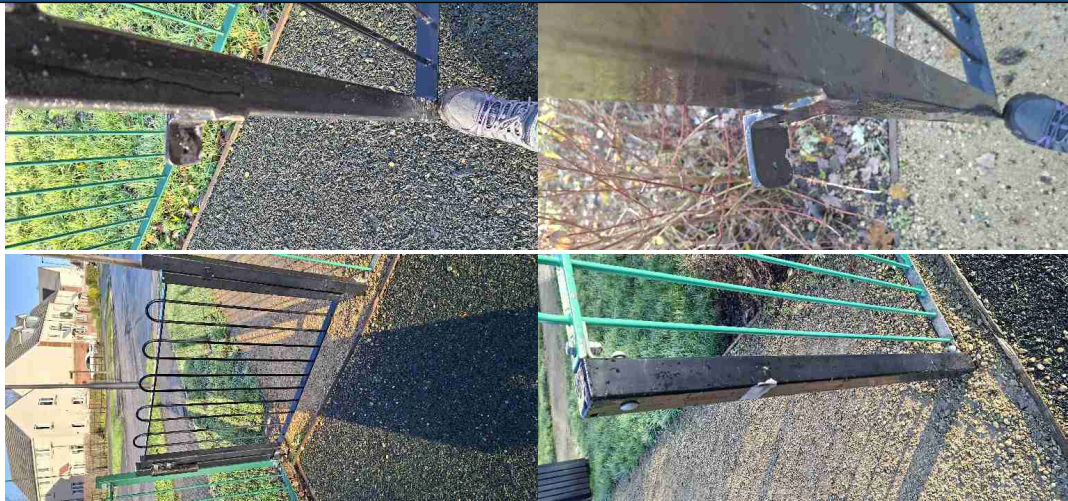
Status:	InProgress	Category:	
Audience:	Private	Assignee:	Remus / CDF Rachel Harling
Target Completion Date:		Next Action Date:	10/12/2025
Importance:	High	Subject:	Gate issues - Coatley Close Play Area
Description:	<p>Neither of the gates have rubber stopper - needs to be repaired urgently.</p> <p>Gate nearest to Homington Avenue needs urgent adjustment as it shuts too quickly</p>

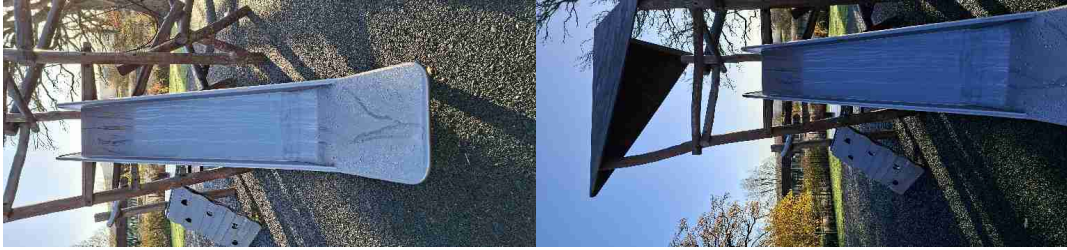
- Climber slide dented, need to monitor for any further deterioration

Small climber slide also dented and needs to be monitored for any further deterioration

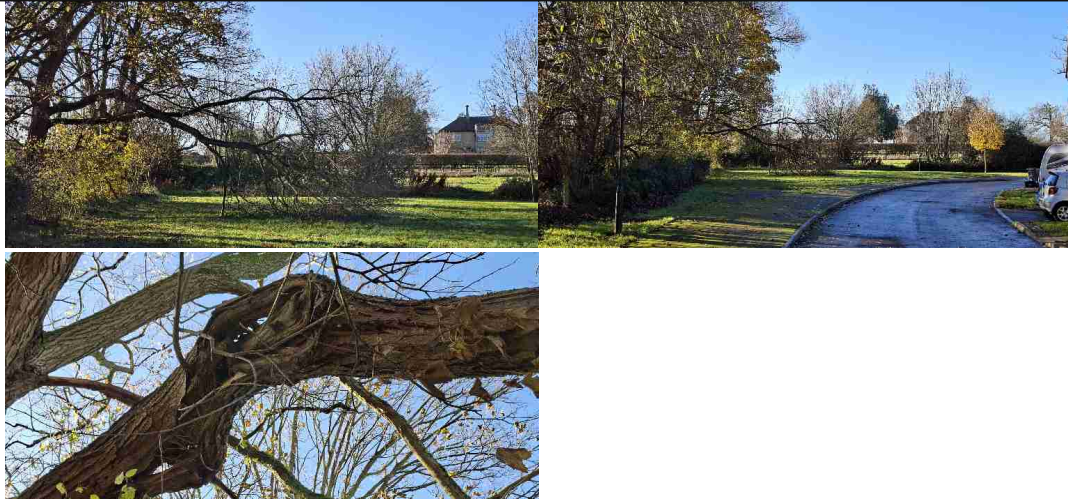
Task:	Question - Badbury Park Estate [7233924]	Process:	Informal
Status:	InProgress	Category:	
Audience:	Private	Assignee:	Remus / CDF Rachel Harling
Target Completion Date:		Next Action Date:	10/12/2025
Importance:	High	Subject:	Large branch half fallen - Belcombe Close
Description:	This needs to be removed as a matter of priority		
Images:

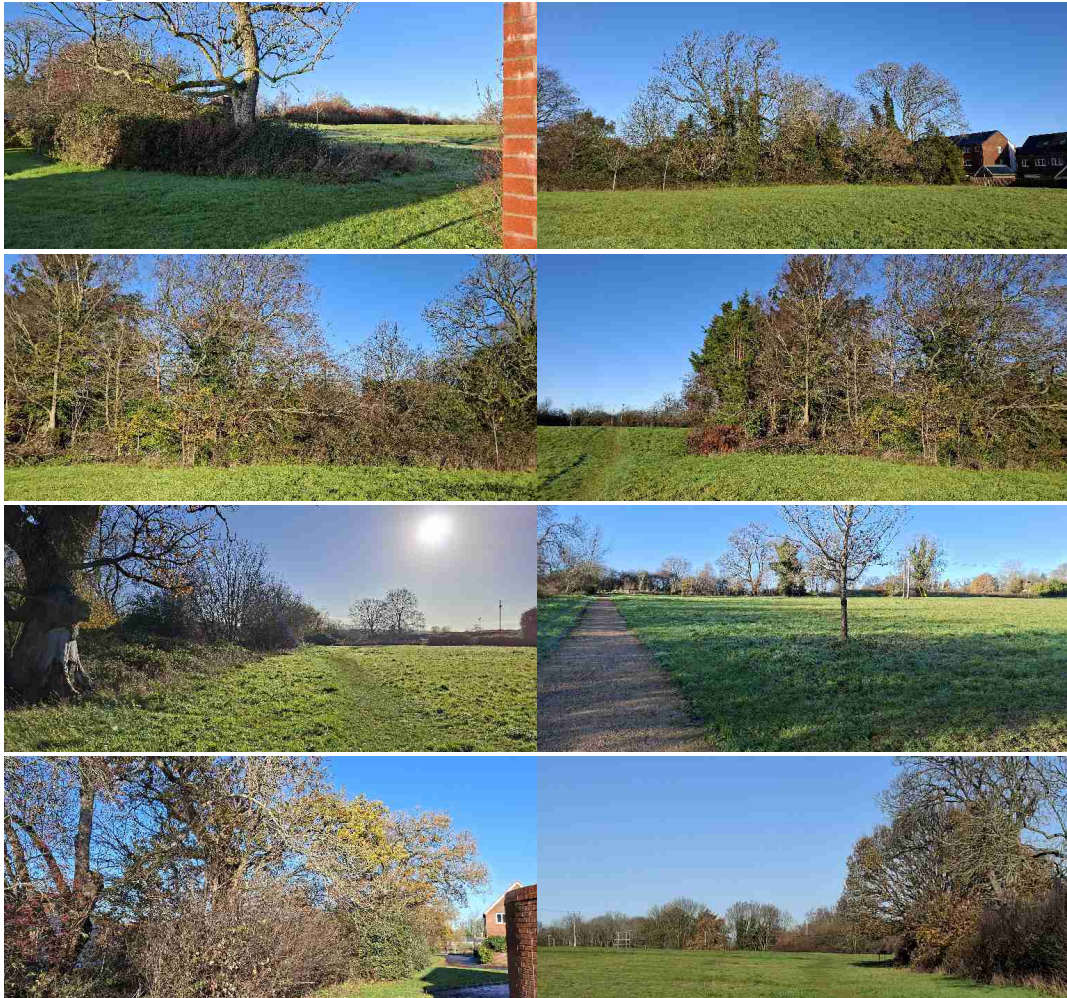
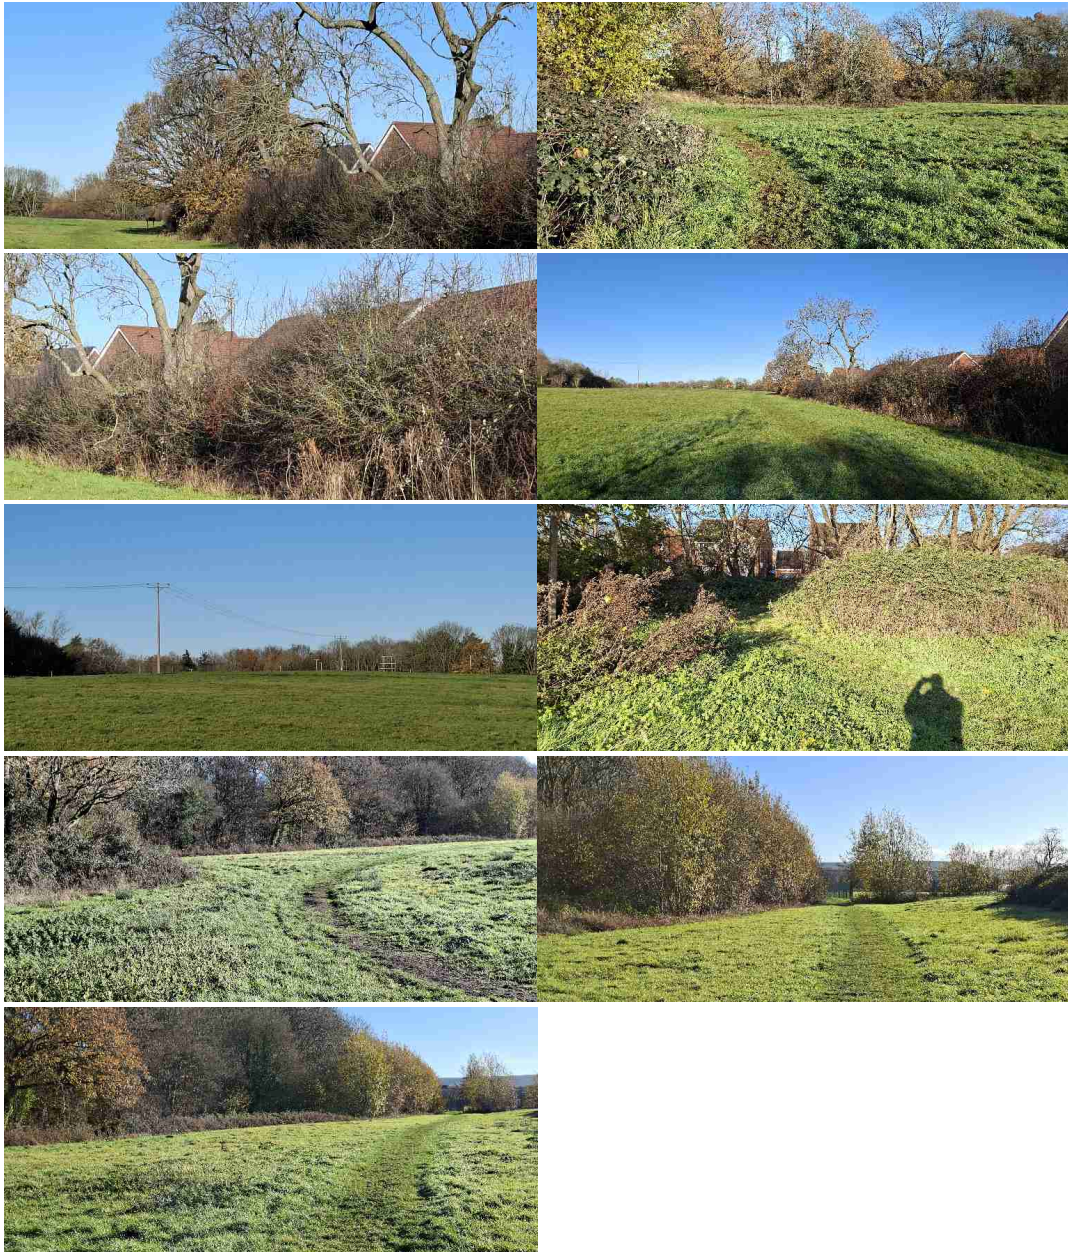
Question	Answer	Change
General condition of mature trees?	Poor	-

- Tree Survey is due to be undertaken within the next few days to allow us to establish what works are required and to what timescale

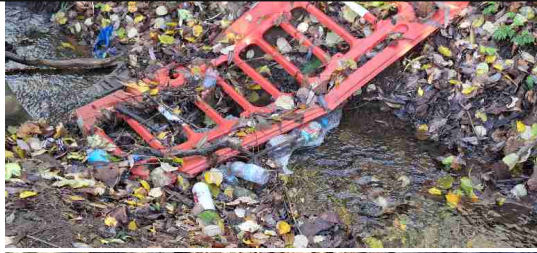
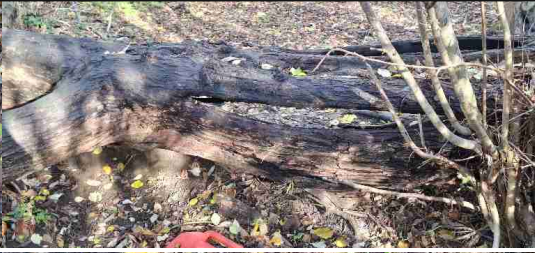
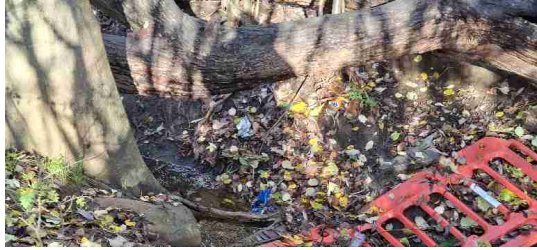
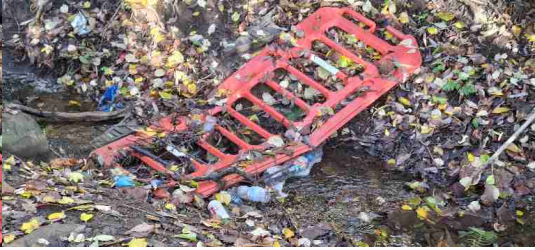
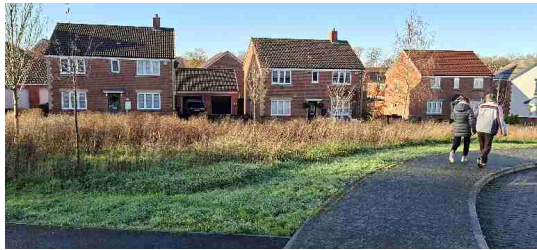
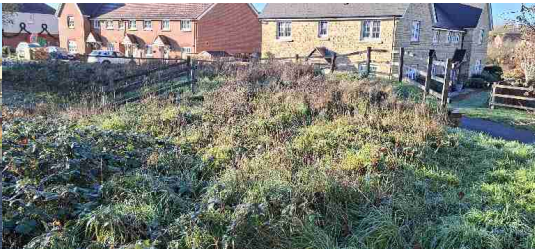
Task:	Question - Badbury Park Estate [7233926]	Process:	Informal
Status:	InProgress	Category:	
Audience:	Private	Assignee:	Remus / CDF Rachel Harling
Target Completion Date:		Next Action Date:	10/12/2025
Importance:	Low	Subject:	Landscaping areas that should be actioned as per current contract
Description:	<p>All paths, including hogging paths to be weeded</p> <p>Wildflower Areas - to be cut annually - some areas have not been cut - see photos</p> <p>Pruning - over entire site including any tree limbs not requiring climbing</p> <p>Weeding of planted areas - weeds to be managed</p> <p>Fertiliser - applied annually to flower beds</p> <p>Leaf collection - to be collected and mulched in a suitable location on site</p> <p>Attenuation Basins - inlets and outlets to be inspected at every visit and kept clear of debris.</p> <p>Have received complaints that areas are overgrown and these must be rectified as a matter of urgency in line with the LEMP</p>

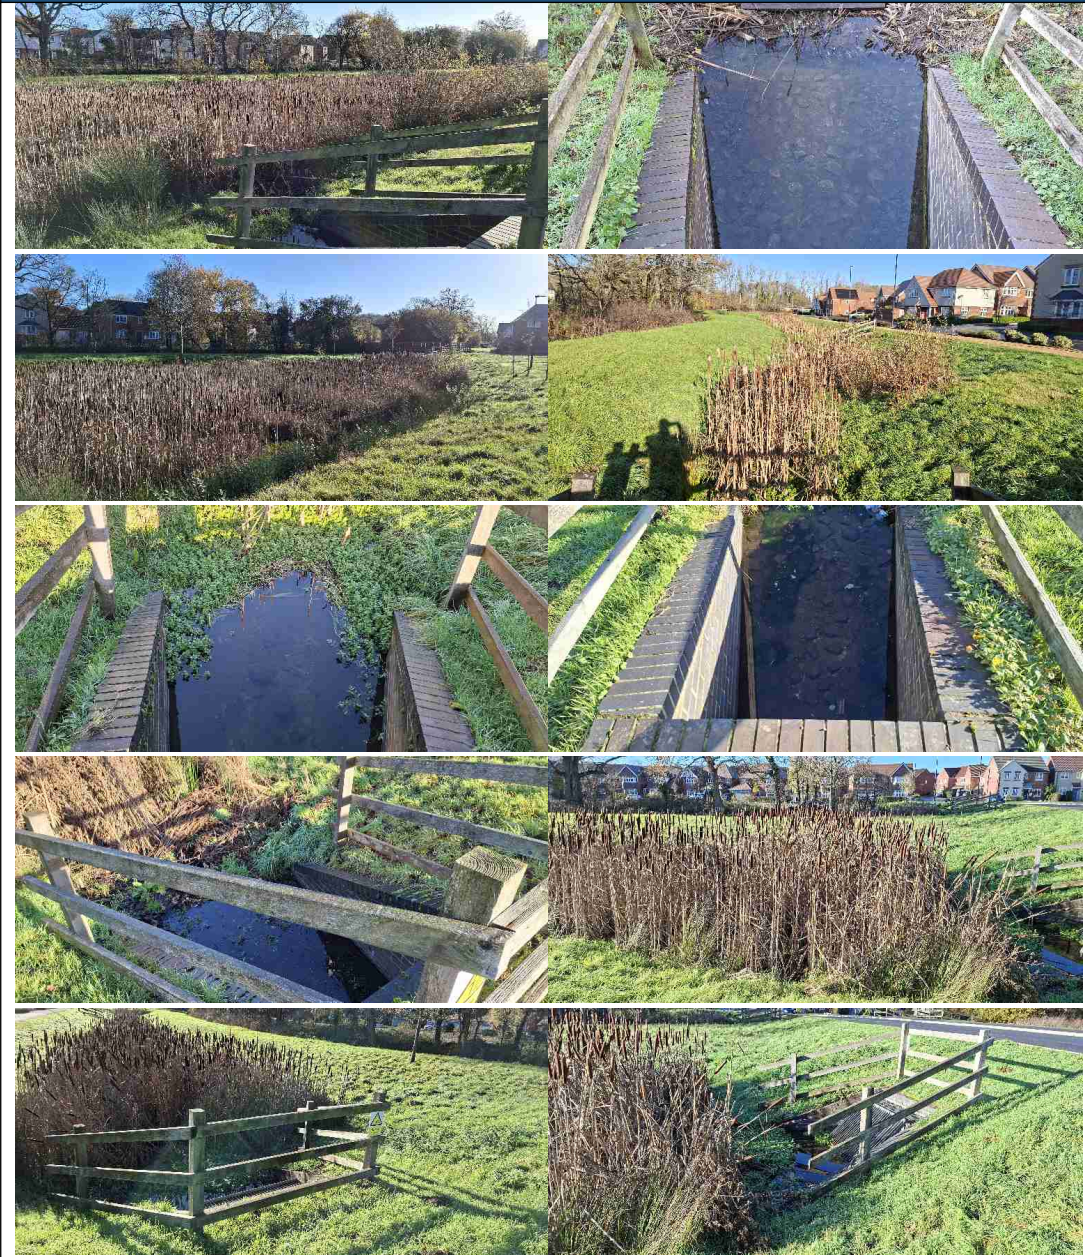
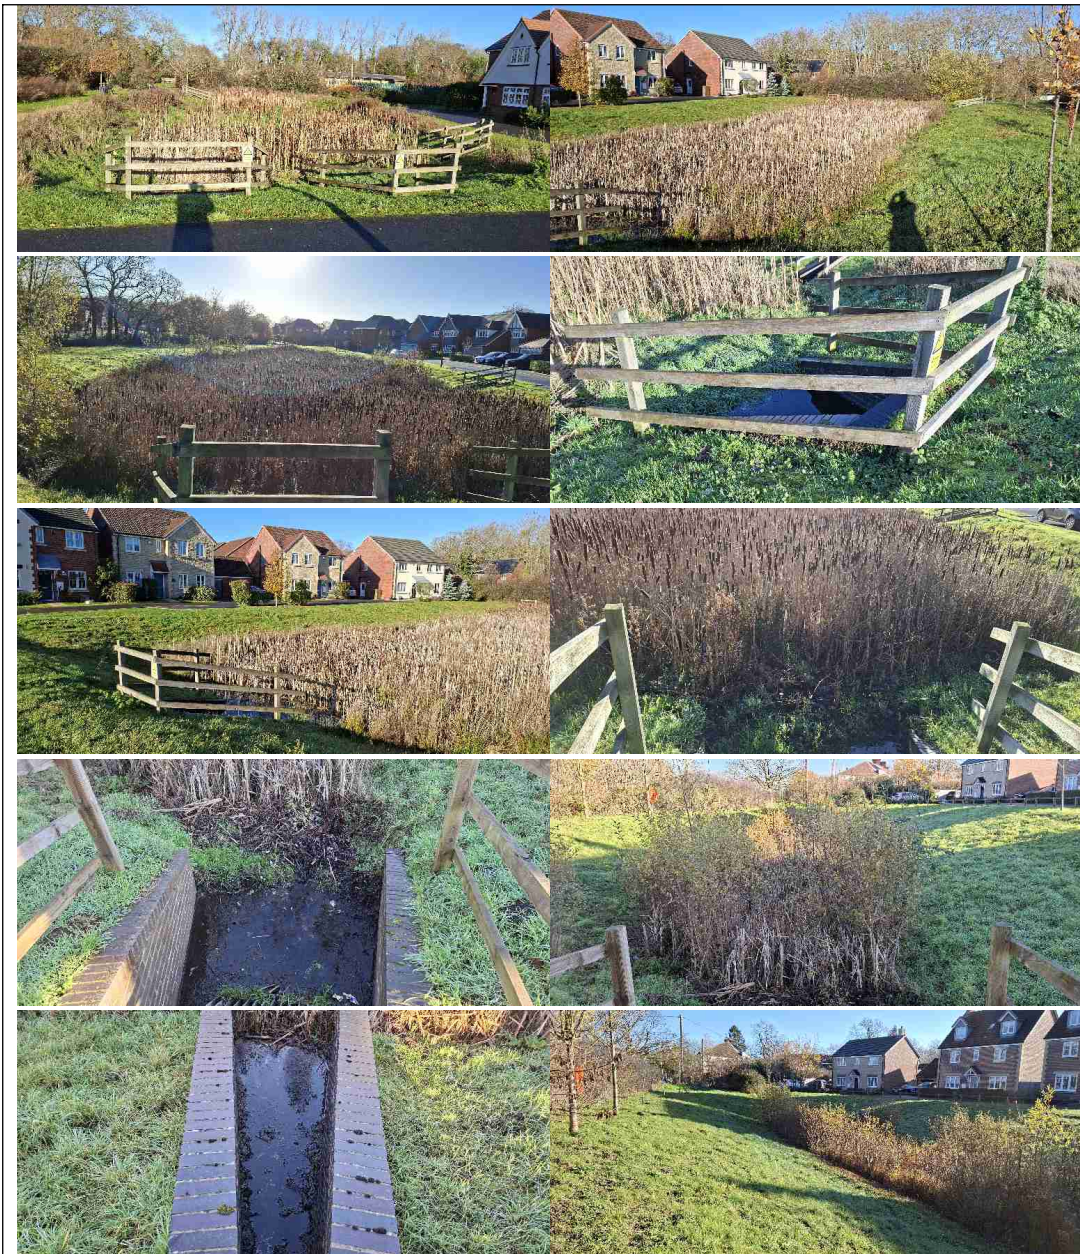
Status:	InProgress	Category:	
Audience:	Private	Assignee:	Remus / CDF Rachel Harling
Target Completion Date:		Next Action Date:	10/12/2025
Importance:	High	Subject:	Suds / basins all need work
Description:	All overgrown, full of debris and silt - need urgent work to clear back as per LEMP

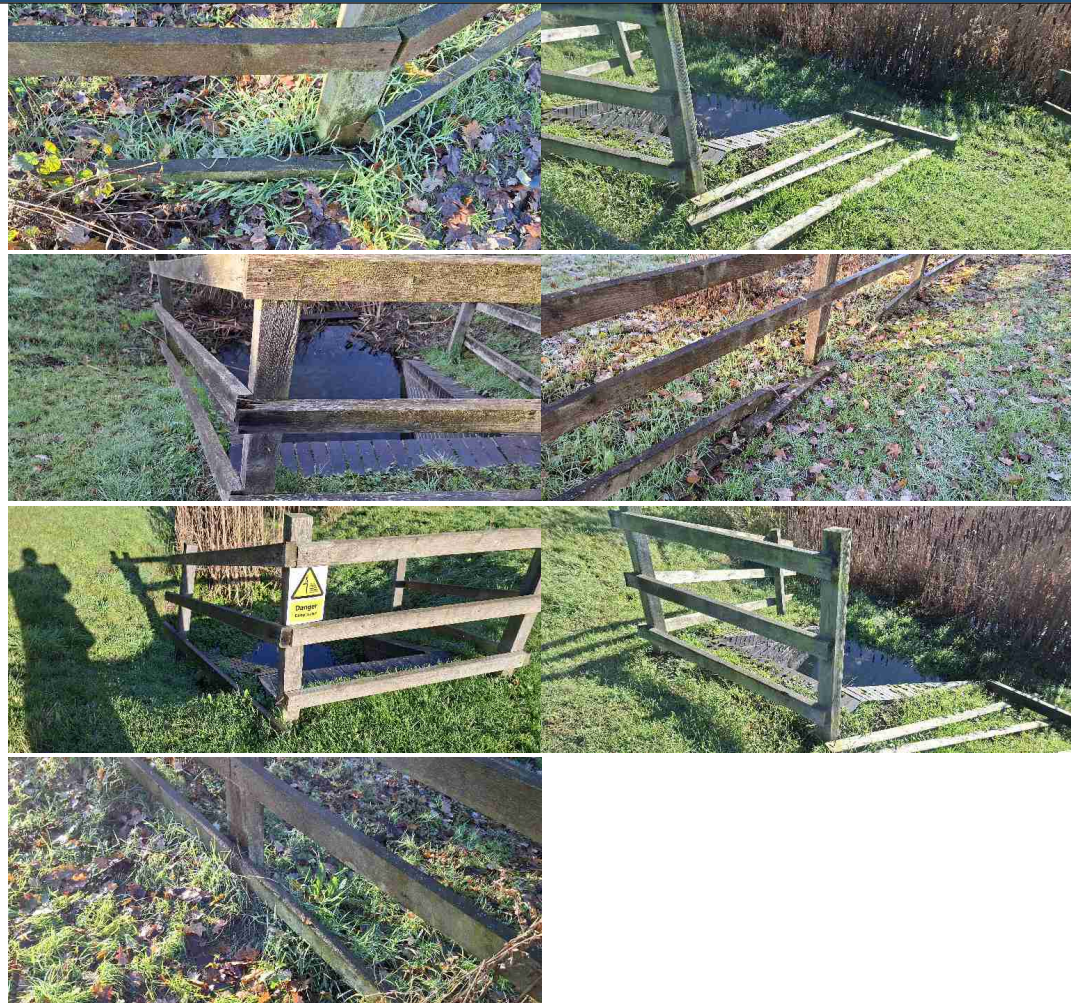
Task:	Question - Badbury Park Estate [7233929]	Process:	Informal
Status:	InProgress	Category:	
Audience:	Private	Assignee:	Remus / CDF Rachel Harling
Target Completion Date:		Next Action Date:	10/12/2025
Importance:	High	Subject:	Broken fences to be repaired around SUDs
Description:	These are needed at various locations throughout the development
