Building Badbury Park Estate

Survey Start Time today, 03/12/2025 at 18:50

By Rachel Harling

1.1 Play Area behind Ashcombe close

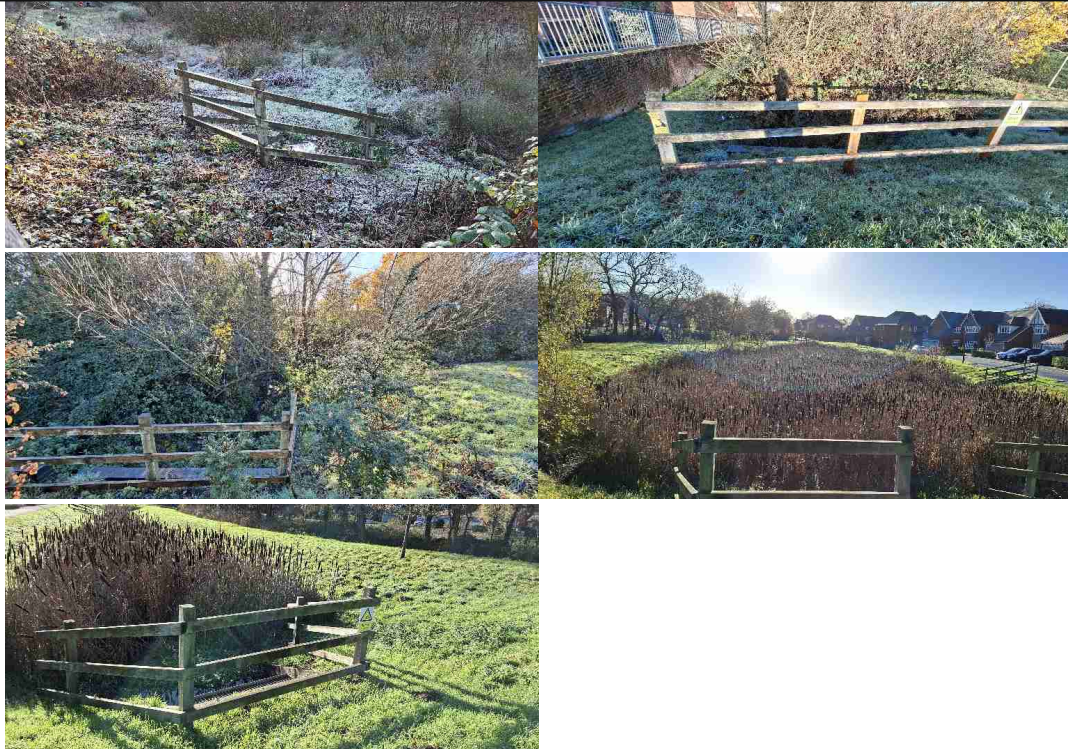
Task:	Question - Badbury Park Estate [7233930]	Process:	Informal
Status:	InProgress	Category:	
Audience:	Private	Assignee:	Remus / CDF Rachel Harling
Target Completion Date:		Next Action Date:	10/12/2025
Importance:	High	Subject:	Extra "Danger Deep Water" signs are required around various locations throughout the site
Description:	See photos...		
Images:

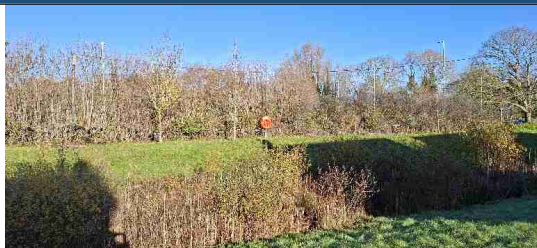
Task:	Question - Badbury Park Estate [7233931]	Process:	Informal
Status:	InProgress	Category:	
Audience:	Private	Assignee:	Remus / CDF Rachel Harling
Target Completion Date:		Next Action Date:	10/12/2025
Importance:	High	Subject:	Life buoy - clarification and advice required
Description:	Only x1 life buoy on site - will get further advice on numbers and locations
