**Buckingham Road, Heaton Moor**  
**Letter Report**

This report provides a summary of the chemical analysis of the sub-base material below the existing derelict all-weather pitch at Peel Moat Public Open Space, off Buckingham Road, Heaton Moor.

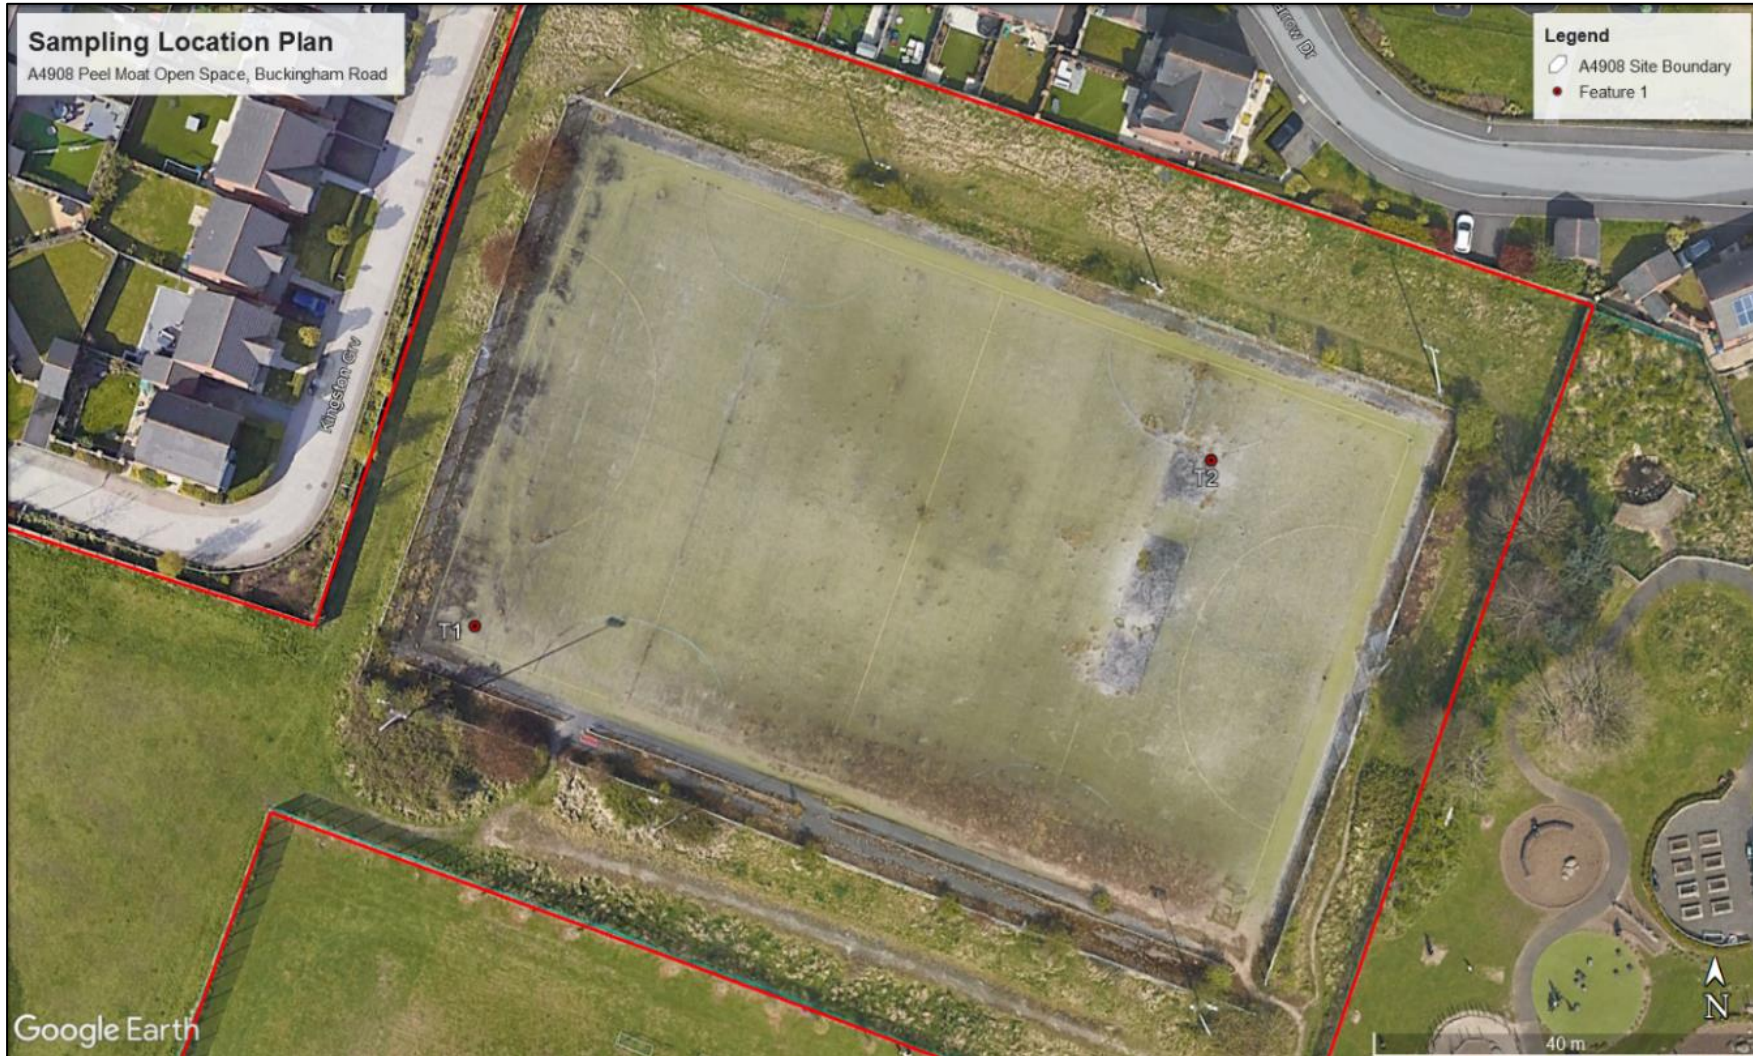
**Figure 1: Sampling Location Plan**

Sample locations for the stockpile samples are shown in Figure 1 overleaf.

Two samples of the rubber sub-base were obtained for chemical testing from the locations shown in Figure 1.

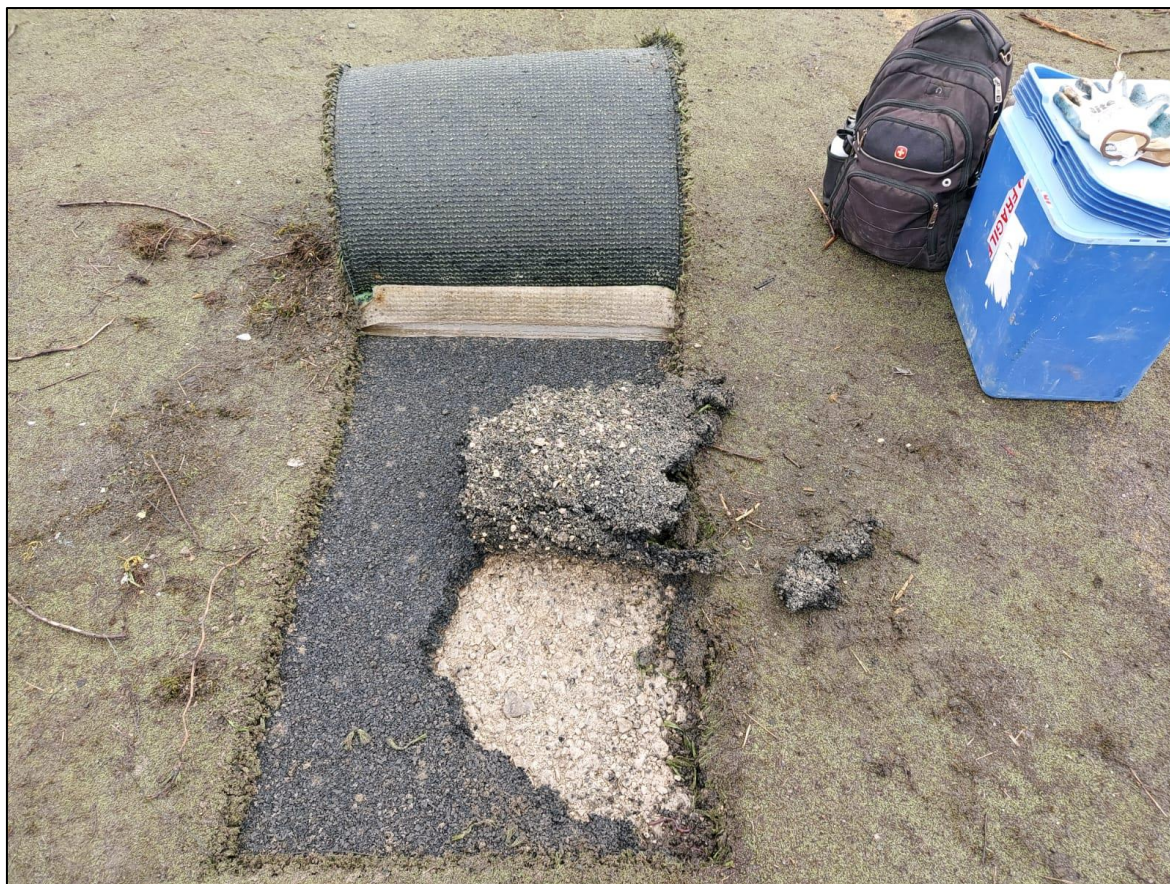
**Figure 2: Observed Ground Conditions (T1)**

During the site visit the ground encountered comprised 50mm of old, all-weather turf, overlying 100mm of compacted rubber chippings, overlying compacted, grey sandy GRAVEL of concrete and limestone. For the purpose of this exercise, the thickness of the gravel material was not identified.

There was no visual and olfactory evidence of contamination during the site sampling process.

Figure 2 below shows an image of the ground conditions observed during the sampling process.

However, both samples have been classified as Hazardous for the purpose of off-site disposal in accordance with the Environment Agency guidance WM3.1, due to elevated zinc (T1) and TPH (T2).
