Barrack Lane j/w Cherry Garden Road, Great Waltham

2022/2023 Technical Note
17 October 2022

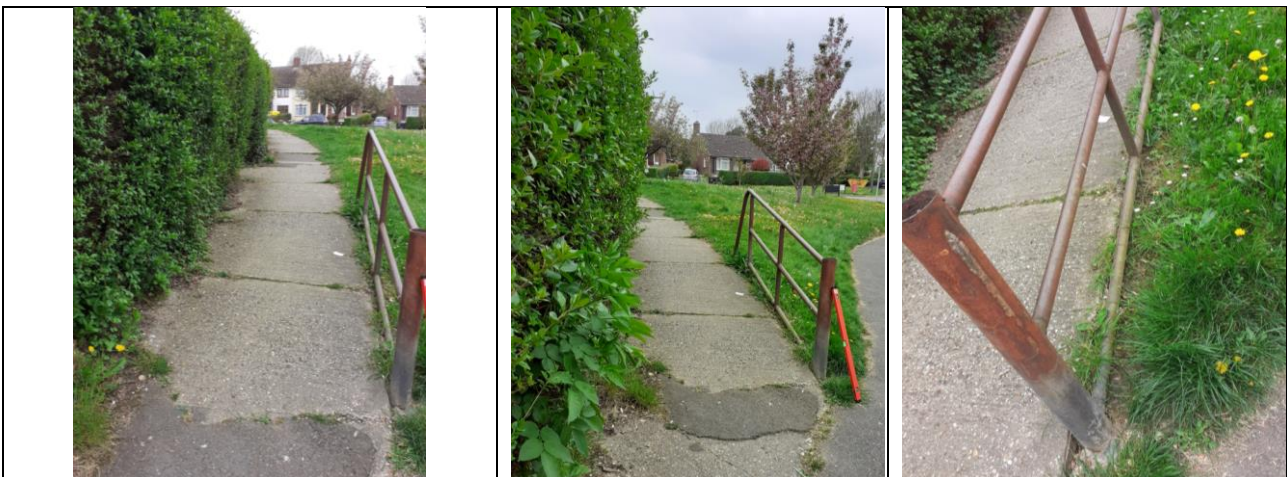
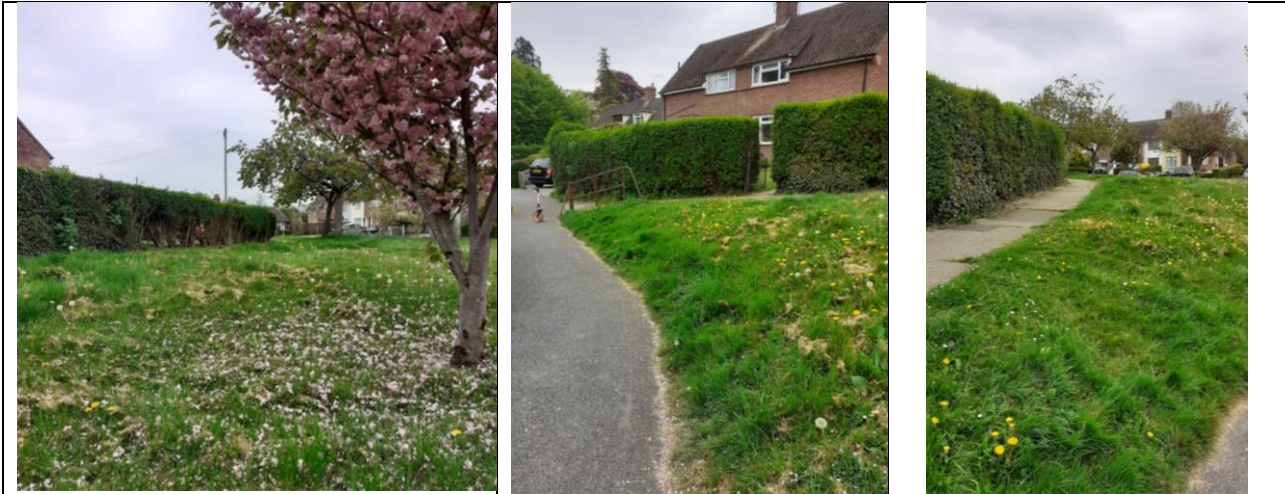
- **Footway n.1** (55m total length) For the first 54.1m of its length the slope is acceptable but on the last 0.9m the slope becomes very steep, around 21.6%. The surface has been made with concrete slabs that currently are in a poor condition, making it difficult to use for all pedestrians, especially for less able-bodied users.
- **Footway n.2** (58m total length) For the entire length the slope is acceptable, providing a more practicable way for all pedestrian use. The surface is constructed of asphalt concrete and is in a good condition.

Fig. 1.5.1 Looking south of Footway n.1 showing the poor condition of the concrete slabs and of the existing pedestrian guardrail, also the profile pictures showing the variable slope along it.

As shown in the images above, currently there is an old pedestrian guardrail that just covers the steeper section of the footway. This proposal is to provide a new pedestrian guardrail and extend its length for a minimum of 20m or the entire length of the footway. This could be a support for all the pedestrians and which costs would be reasonable.

Given the complexity of Option 1 described above and the substantial costs required, my recommendation is to progress with Option 2.
