Energy Efficient Warmer Homes

Terena Plowright
Greening Campaign
TerenaPlowright@gmail.com

So why is
thermal
imaging
important?

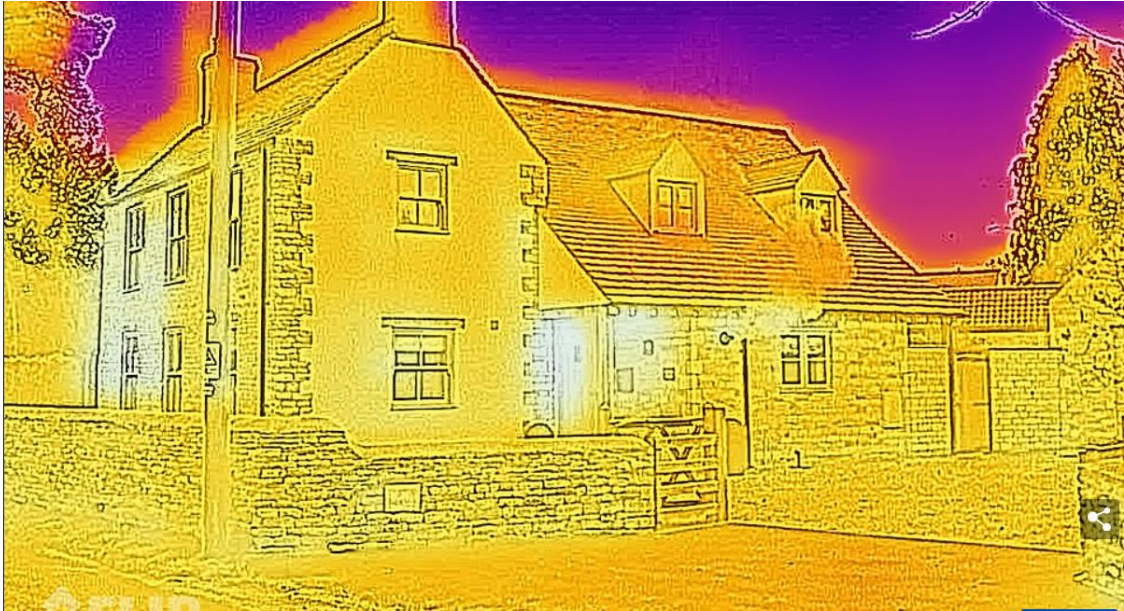
Good insulation as the house walls are a similar colour and temperature to the garden wall and the ground, meaning that the heat is trapped inside the house.

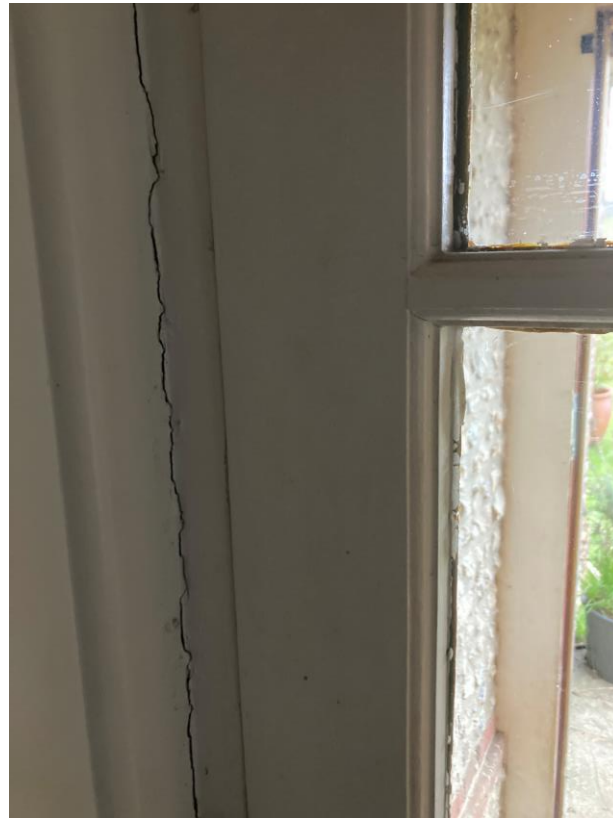
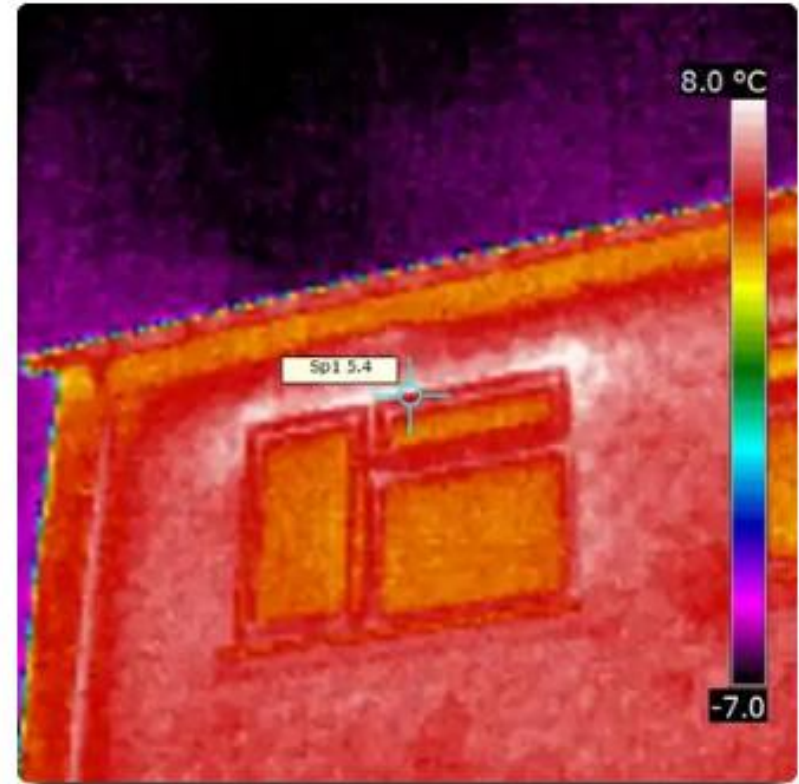
Windows

Heat escaping from above and down the side of the window suggesting a bad seal around the frame.

- Demonstrates the reflective properties of glass as can see the house behind.

- Leaking from top of door/window can sometimes be corrected by adjusting the hinge.

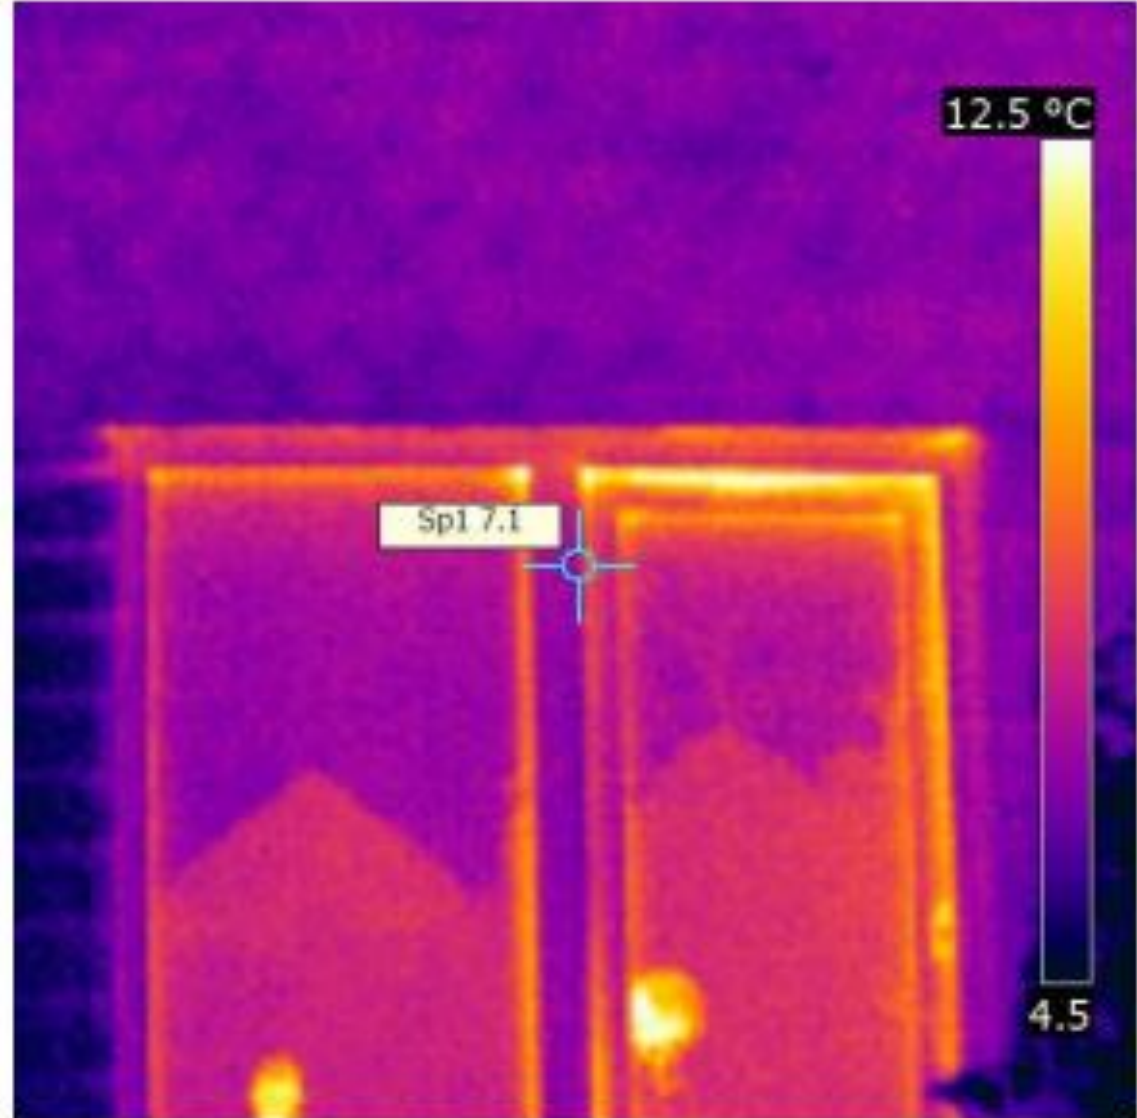
Different effectiveness of double-glazed units in terms of insulation performance. The windows may have lost gas or vacuum over time and now result in higher heat loss. The glazed patio door seems to be a newer unit.

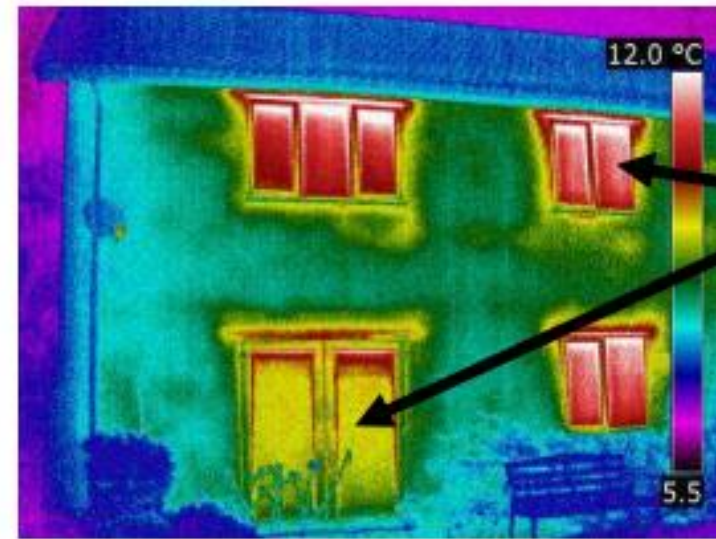
Higher heat loss from windows compared to patio door.

-
- Also, the same image highlights possible gaps in cavity wall insulation where it may have settled over time.
 - And thermal bridging above the windows and patio door where lintels or support beams have not been insulated and are conducting heat from the property.

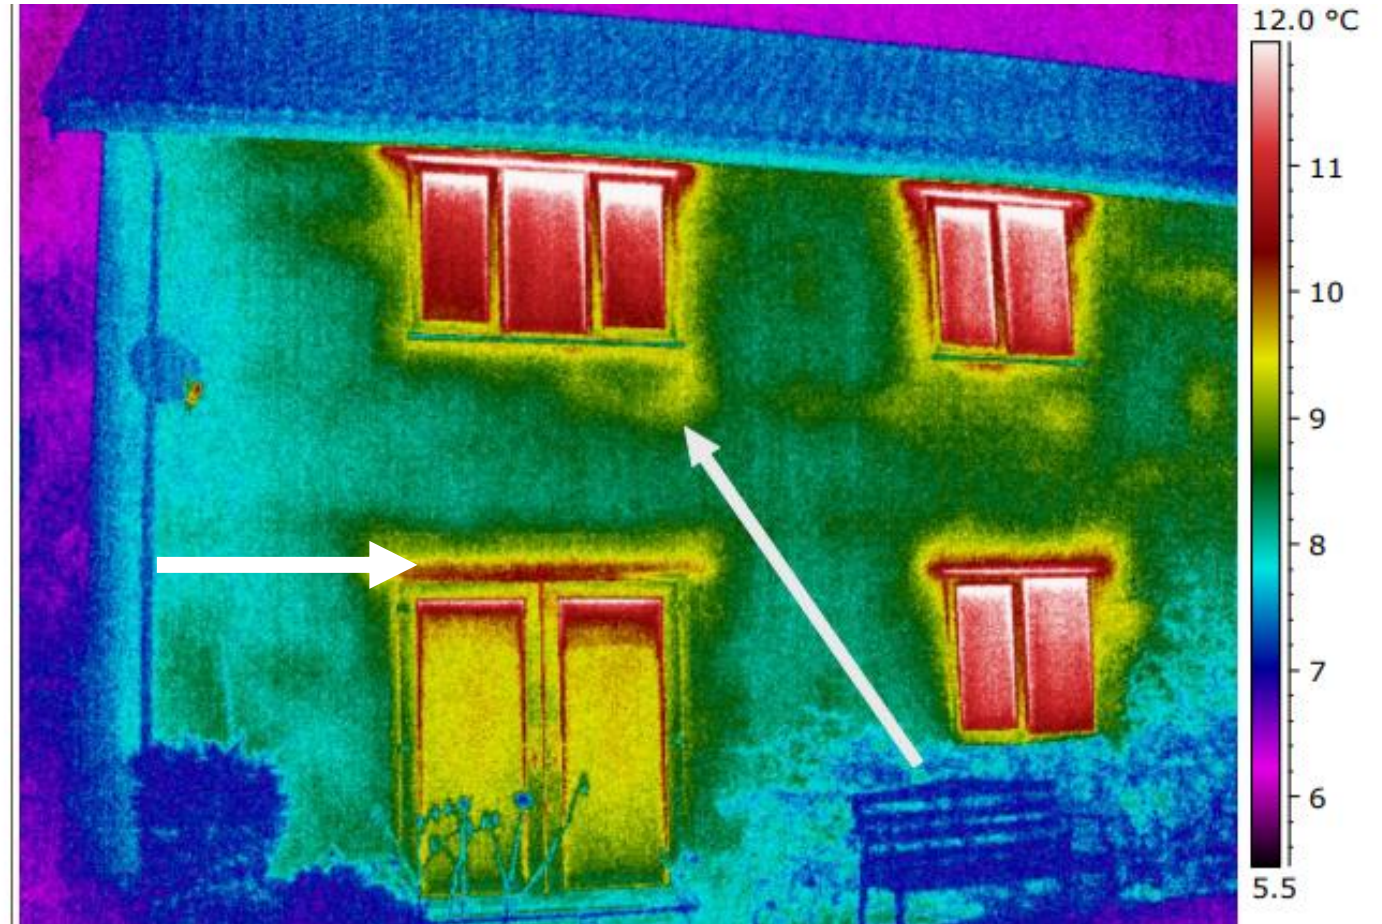
Heat loss through lintels

Low heat loss

Potential
deteriorated
insulation

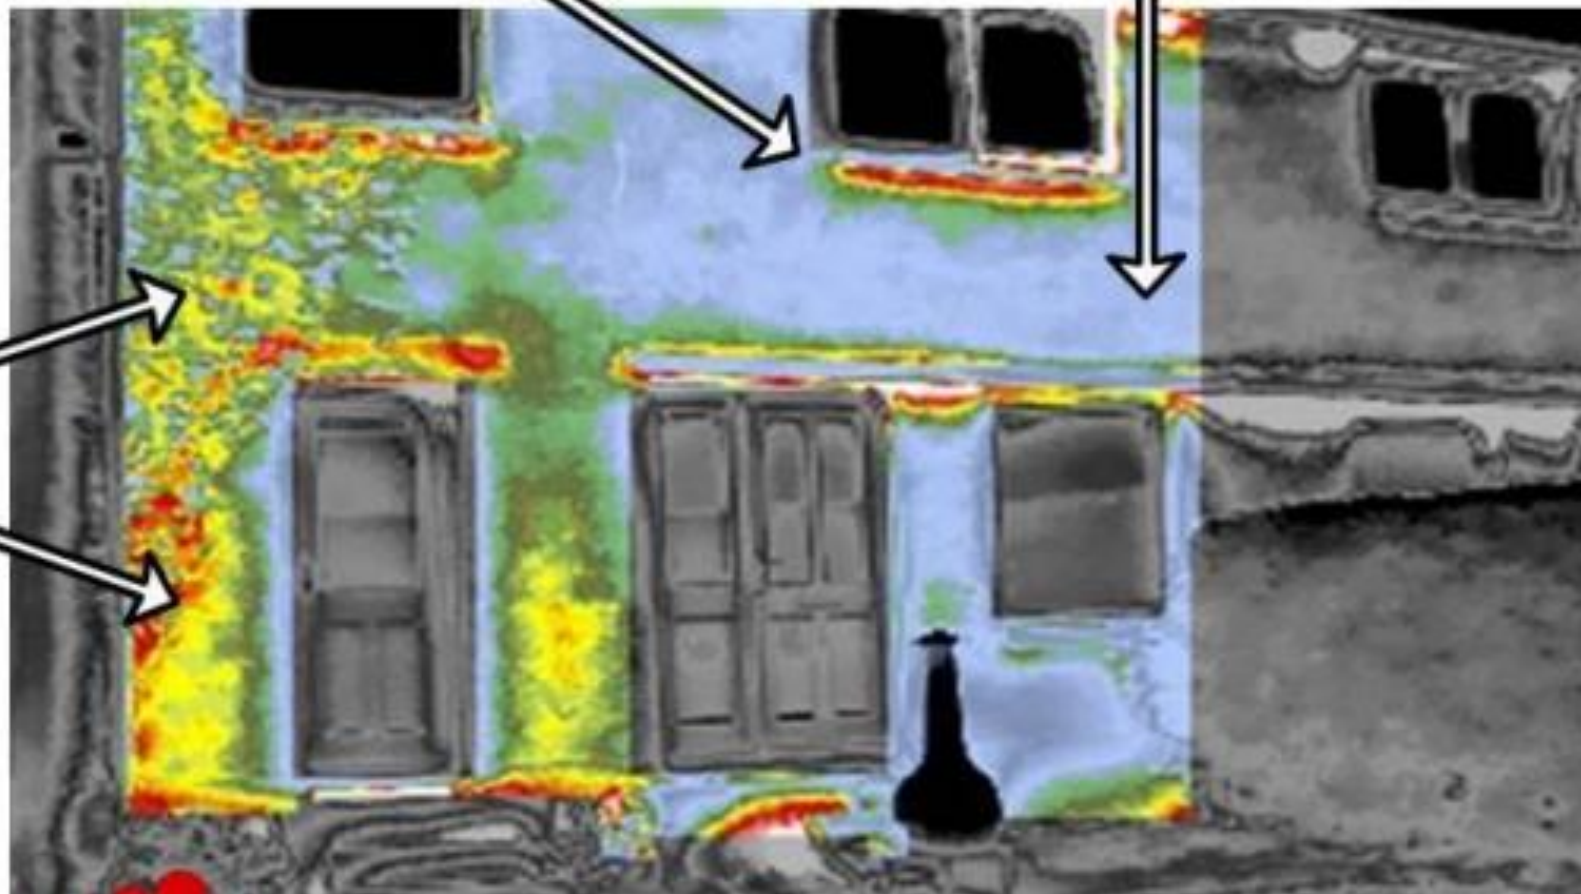
Poorly insulated dormer space

Windows also losing heat

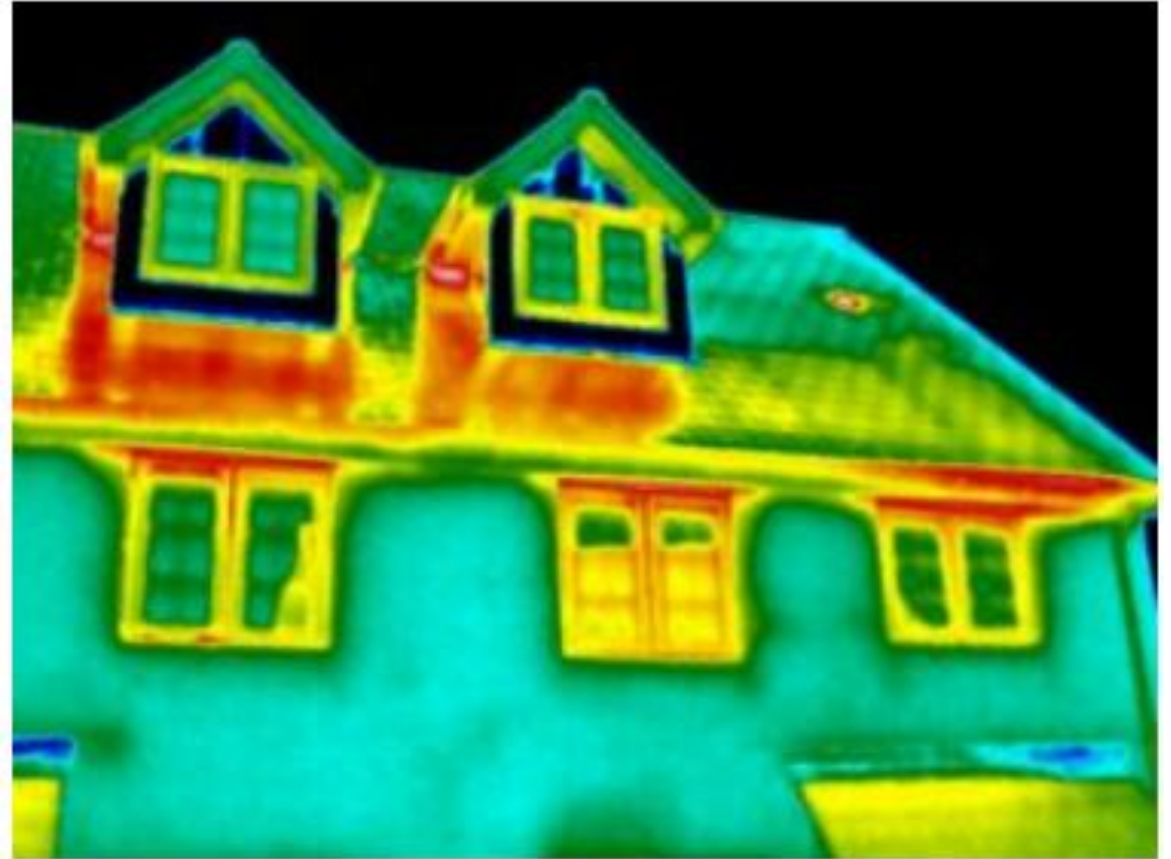
- Insulation has not reached the roof apex

- Insulation not between the ceiling joists creating a bridge

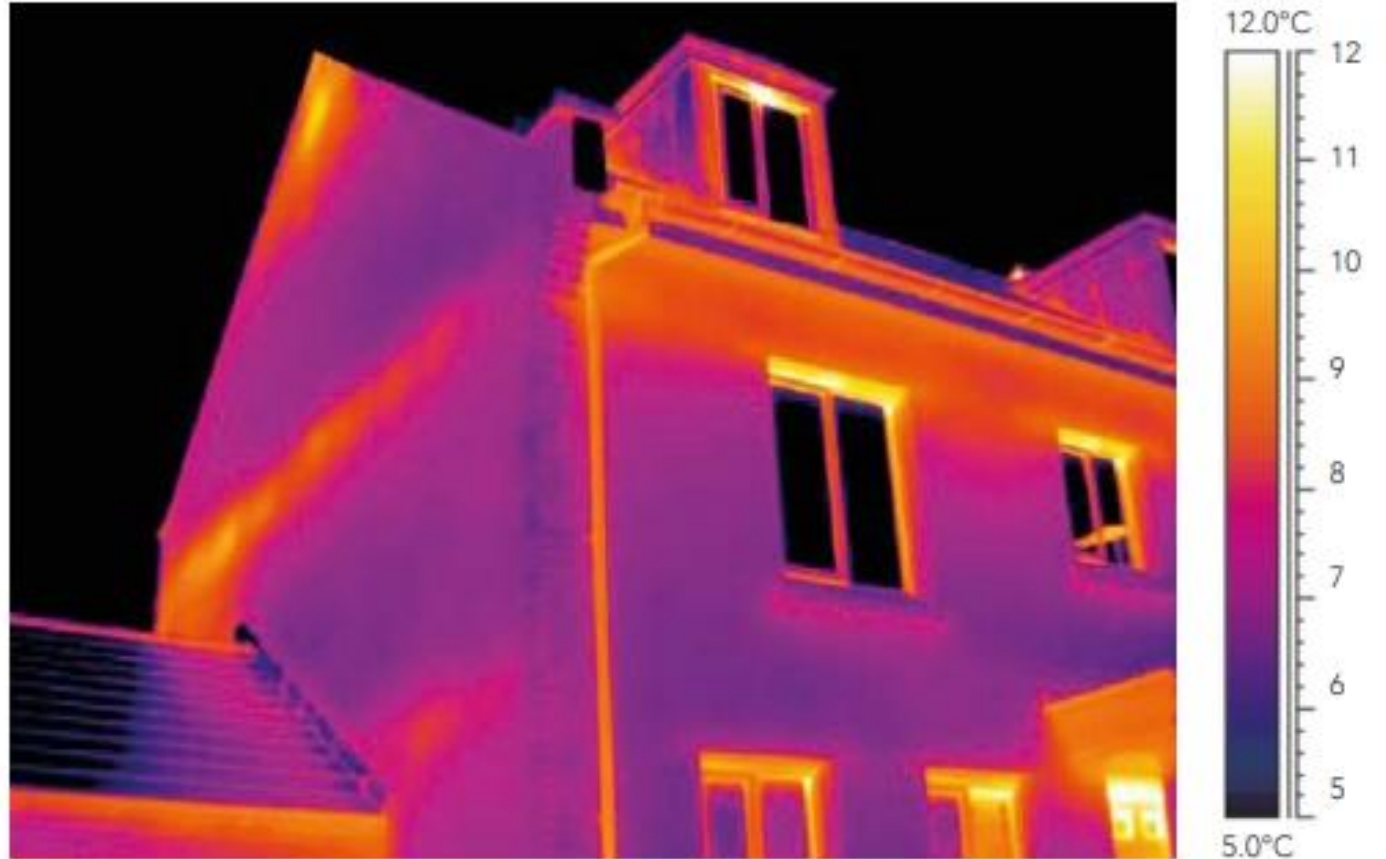
-
- Heat leaking from where different sections of the building join incorrectly allowing heat to escape

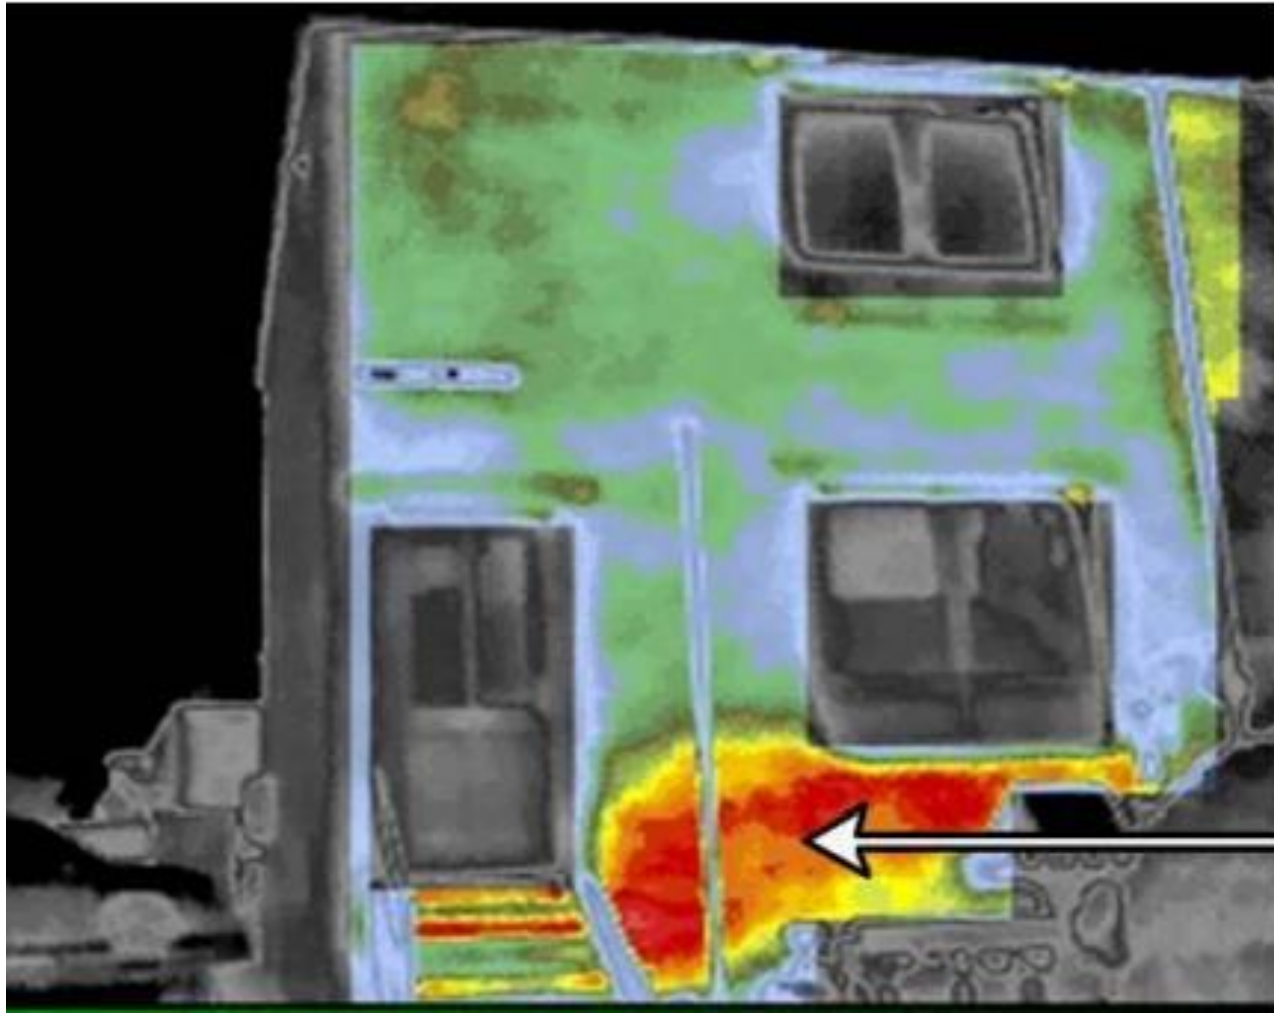
Possible
heat loss
from radiator

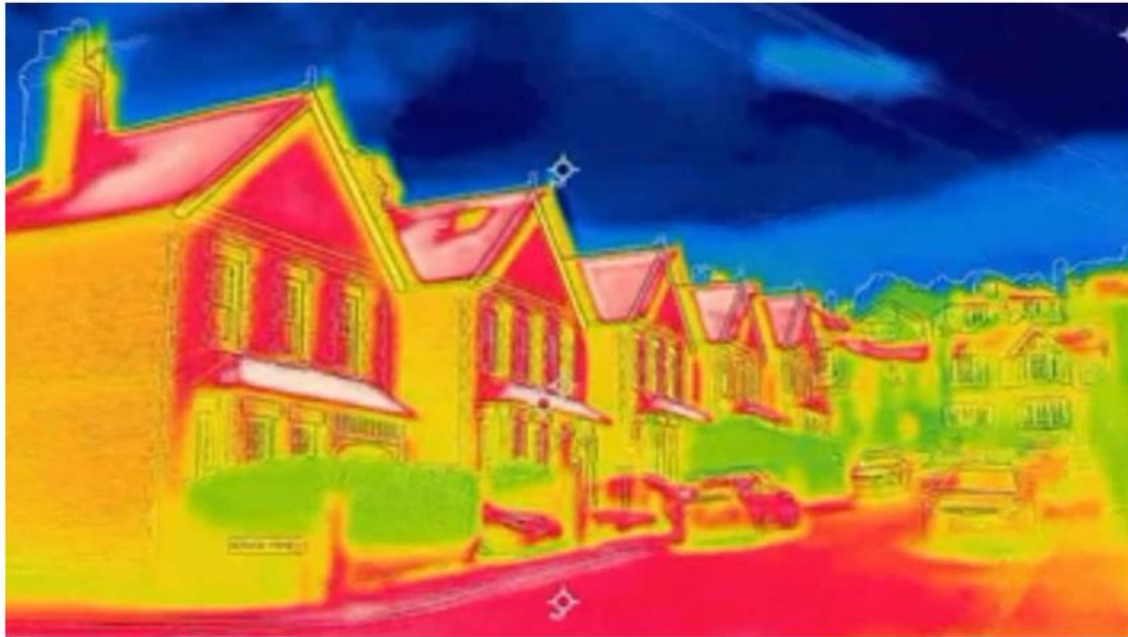
A thermal image showing a street, with houses and the road radiating heat

On a thermal camera it's clear to see the heat radiating from hard surfaces such as brick, steel, concrete and asphalt.
