Environmental Quality Appraisal of the River Ems

A Report to EA, Sussex Area, Worthing June 2007

Dr Nigel T H Holmes
ALCONBURY ENVIRONMENTAL CONSULTANTS
The Almonds, 57 Ramsey Road, Warboys, Huntingdon PE28 2RW, UK
Tel: 01487 822020; Mobile: 07957 424887
EMAIL: n.holmes3@btinternet.com

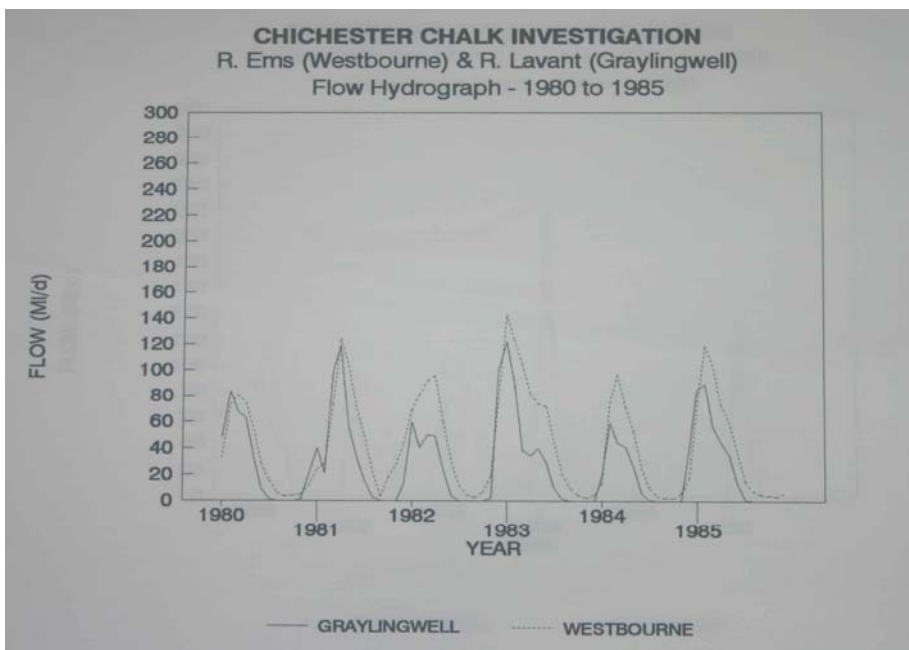
Figure 1c Example hydrograph showing closely related hydrographs of the Ems & Lavant (from Halcrow, 1994)

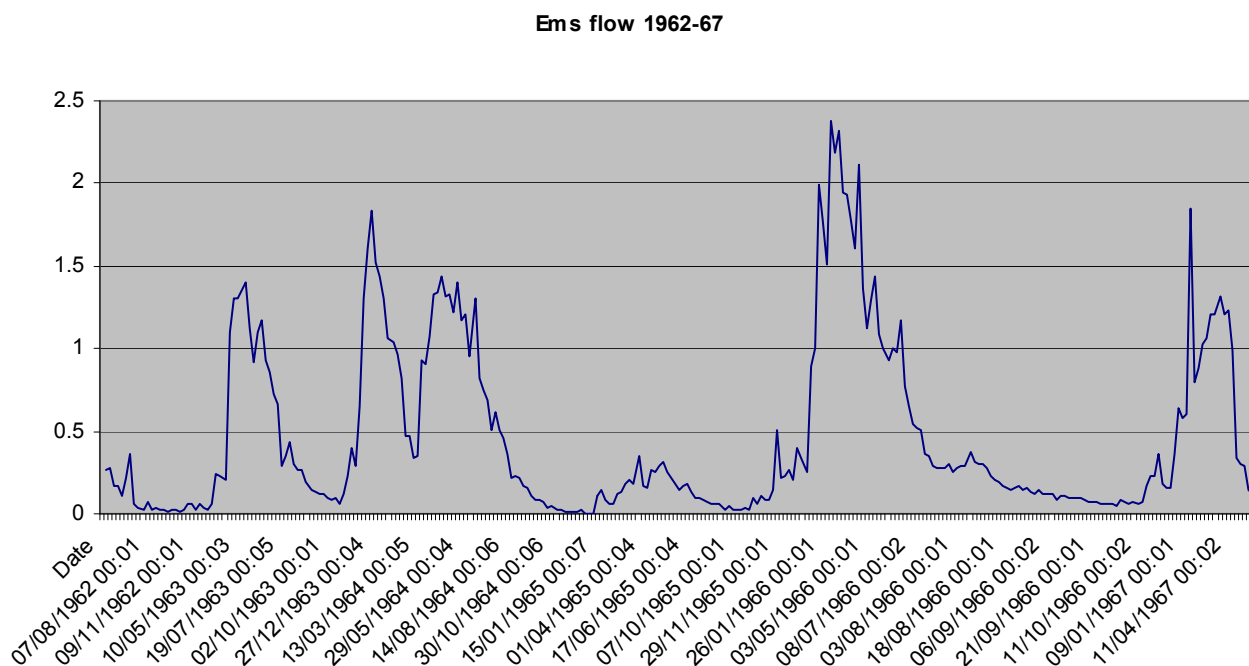
Figure 3.2.1d Flow (discharge in cumecs) close to the Westbourne gauge prior to installation of permanent gauge

Soon after Walderton become fully operational, there followed the dry winter of 1964/5 (see Figure 3.2.1d), necessitating PWL applying for, and being granted, a drought order to abstract up to 5mgd. According to the files this was not used significantly, but by the end of 1965 PWL wished to conduct pump tests to reveal potential increased abstraction yields. There were many objectors, and a hearing was held in December of that year. Two items of correspondence in the PWL files give concern that environmental considerations were given inadequate attention in the modification of the license in 1968, and that it was a forgone conclusion it would be granted by the regulator.

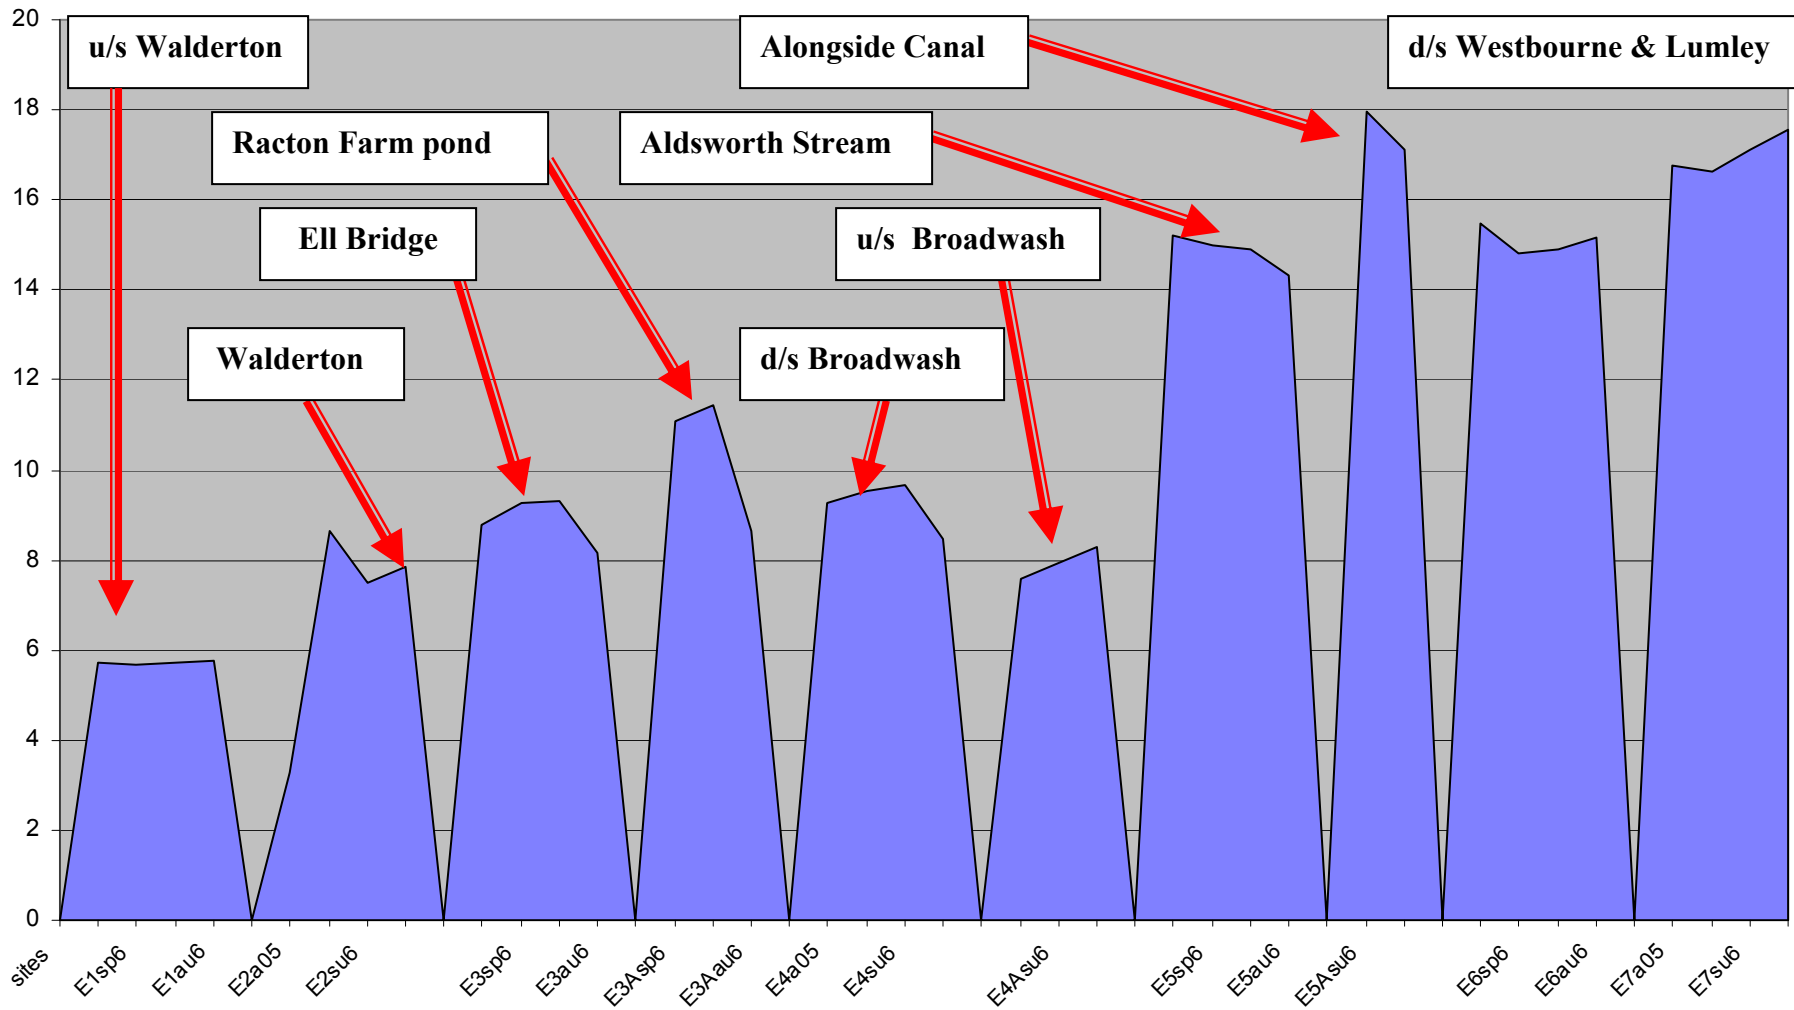
FIGURE 4.4A INDICATION OF DEGREE OF RELIABLE FLOW AS SHOWN BY FLORA – MODIFIED ELLENBERG SCORES WITH LOW SCORES RESULTING FROM A PREDOMINANCE OF DRY LAND TAXA, AND HIGH SCORES INDICATIVE OF COMMUNITIES DOMINATED BY AQUATIC TAXA.

- The lower reach downstream of Westbourne mill has a flora indicative of perennial flow in a chalk stream.

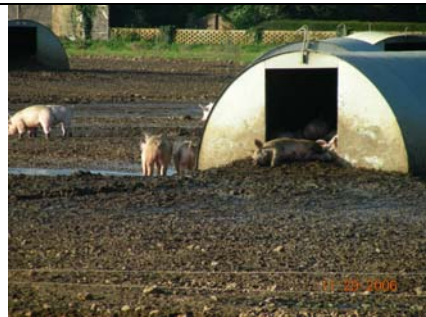
<p>Extensive free-range pig rearing in reach poses potential threat to river siltation</p>	  <p>Silt present in river d/s Racton Park Dell – combined effect of increase in material and over-wide, non self-cleansing channel</p>

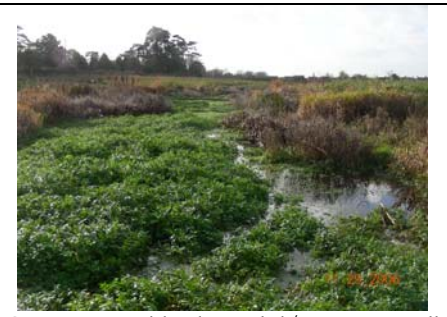
<p>Open, over-wide channel d/s Racton Dell – river and land on either side is SNCI</p>

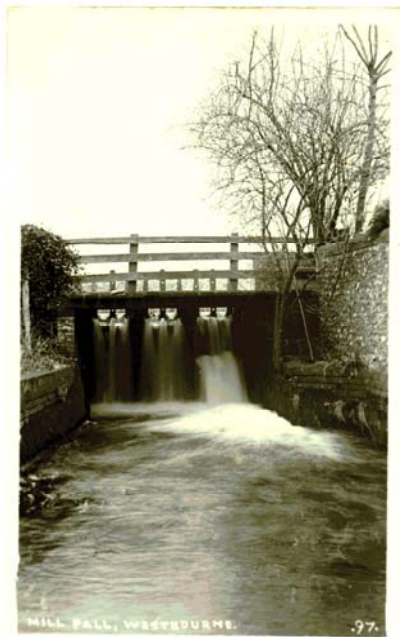
Westbourne Mill sluice – shows big vertical drop and 'challenge' to sea trout

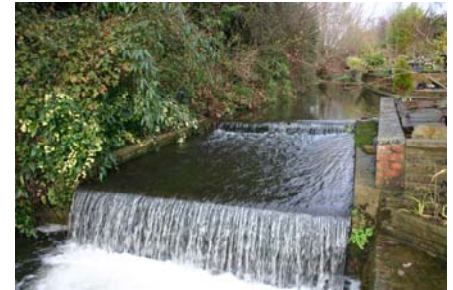
Control Structure on Ems (Wren Centre) d/s Lumley Leat – limits sea trout migration

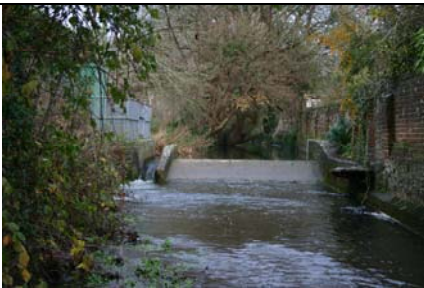
Flow gauge u/s Hampshire Bridge (Westbourne gauge)

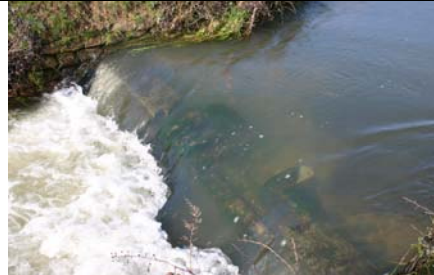
Weir recommended for modification or removal to restore chalk stream habitat – not central slots could be removed
