# Musgrave Church Field Barn

## Protected Species Survey: - bats and barn owl

**Aim:** Bat and barn owl survey of traditional stone barn with restoration impact assessment and mitigation recommendations.

September 2011

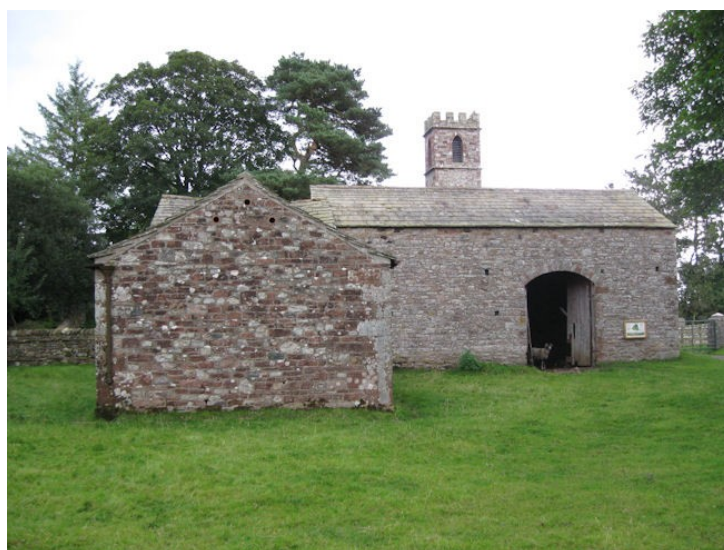
View of front (west elevation) of Musgrave Church Field Barn and nearby church.

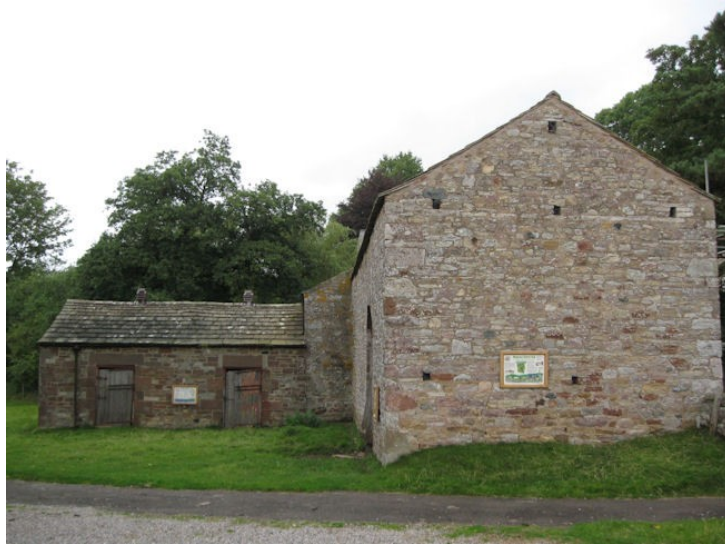
*South-facing gable of the Musgrave Church Field Barn – showing the proximity of some of the mature trees around the barn site.*

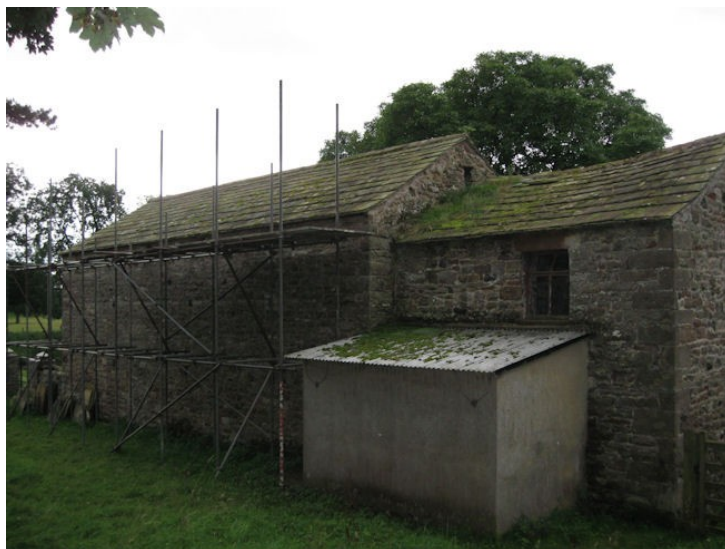
*Rear (east) elevation showing former byre with 'modern' lean-to building.*

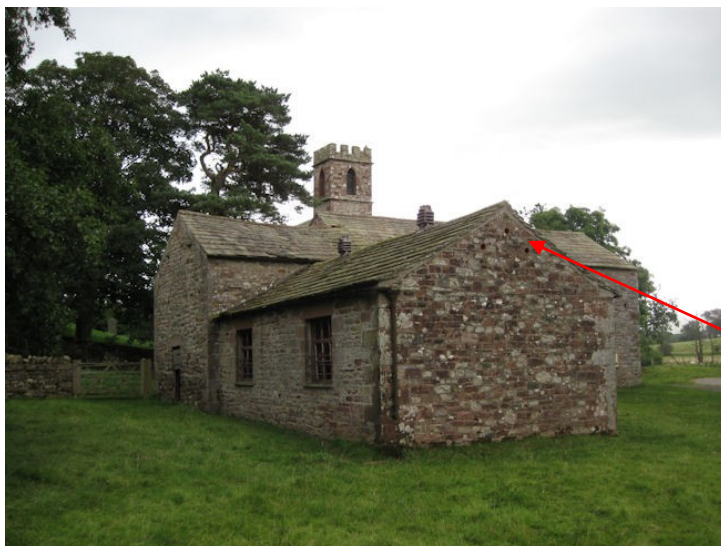
*Rear of former stable annex adjoining barn showing West gable wall with round ventilation holes (red arrow) in the upper section of the wall*

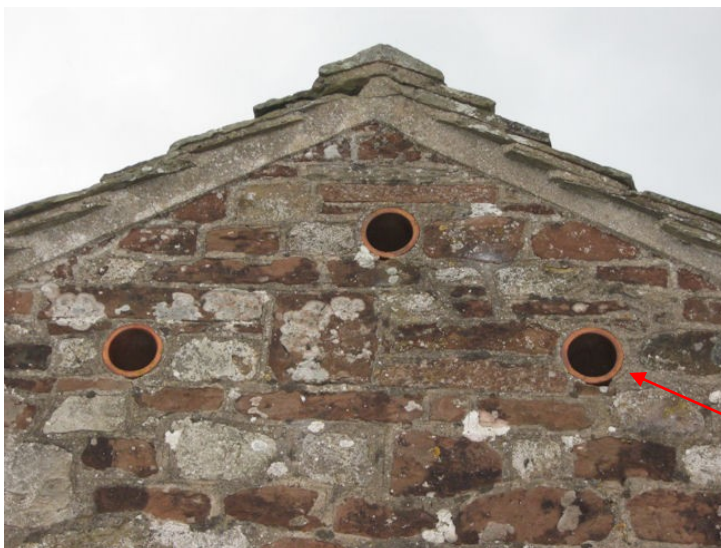
*Close-up one of the round holes that are present in the upper parts of the stable wall*

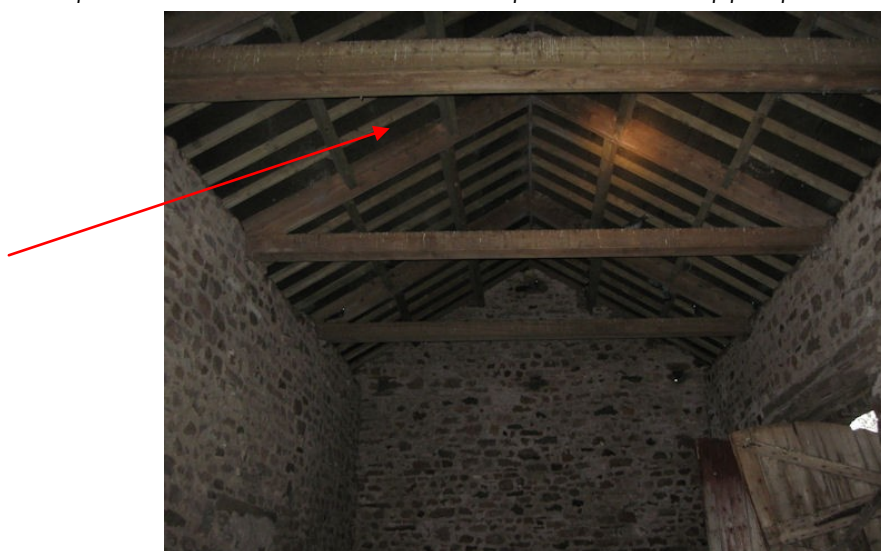
*Interior of church barn showing underside of roof, which includes bitumen felt below the traditional stone flagged roof covering.*

Contractors should not handle bats and should be advised to lift any flags or ridge tiles carefully, in anticipation that bats may be present. If any collections of droppings are found (whether or not bats are found), then access to the roof must be reinstated as close as possible to the same location.
