Client Report No. 402/06

January 2007

MUSGRAVE CHURCH FIELD SURVEY, GREAT MUSGRAVE, CUMBRIA

MUSGRAVE CHURCH FIELD TRUST

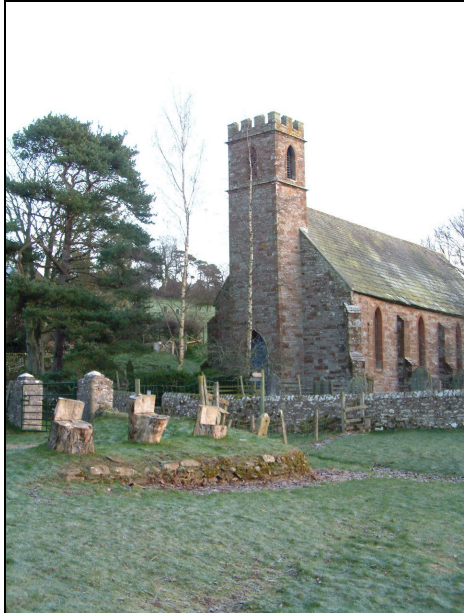
Plate 1. St Theobald's Church, looking northwest

- 3.4.1 St Theobald's Church was originally located a few yards from the river but was prone to flooding. The present St Theobald's church was built in 1845 on higher ground to the previous building at a cost of £550 (Wheelen 1860). This followed the 'great flood' of 1822, during which the church and rectory stood 3 or 4 feet in water, and most of the bridges on the River Eden were destroyed. This church was restored following a fire in 1921 (Plate 1).

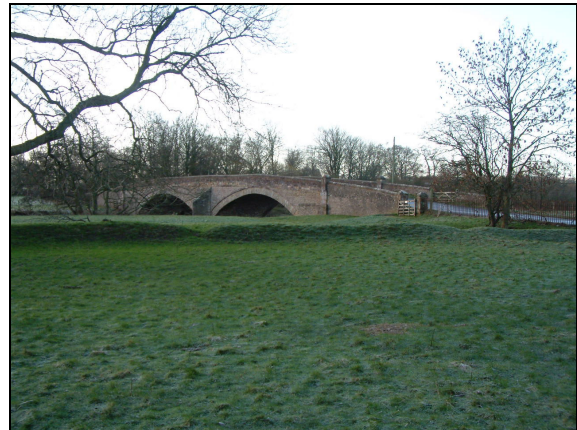
Plate 2. Musgrave Bridge showing the west end of the earthen dyke on the south side of Musgrave Church Field

- 3.4.5 The present stone bridge (HER No.15793) was built in 1825 (Plate 2). However, this bridge exacerbated the flooding of the church and rectory, so in 1829 a 'tunnel' was built next to the bridge to take the overflow water (Curwen 1932, 175-82). It is popularly believed that this bridge replaced a medieval packhorse bridge near the church (HER No.15300), which was destroyed in the floods of 1822.

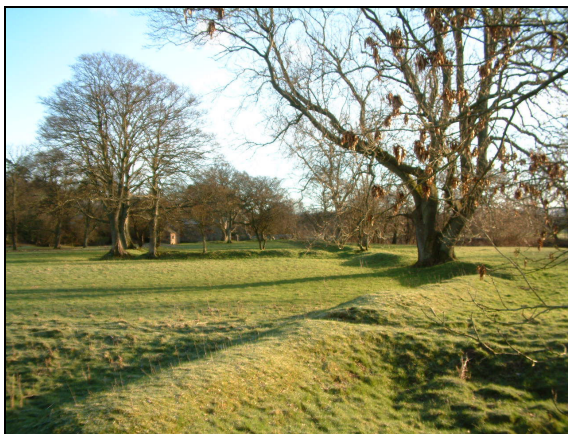
Plate 3. Earthen dyke on the south side of the field, looking east towards the site of the rectory gardens

- 4.1.2 The most notable earthwork was a 153m long, 3m wide and 0.5m high earthen bank or dyke [1], which ran east-west across the entire length of the field (Plate 3). This bank had steeply-sloping sides and a 0.8m-wide flat top. It was straight over most of its length but, turned northwards at the western end (Plate 2), and could be seen to continue in the neighbouring field, across the road to the west. The dyke was interrupted in places along its length, but would have originally formed a continuous barrier, presumably to defend against the flooding of the River Eden. At the east end, the earthwork turned north to meet Church Lane, where it contained stone revetment on the south side (Plate 1). Two stone gate posts marked the location of a former pedestrian gateway at the eastern corner of this earthwork.

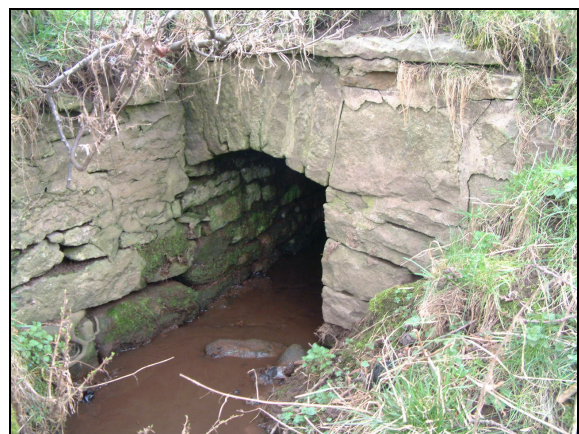
Plate 4. Entrance to a stone culvert at the southwest corner of the field, looking southwest

- 4.1.3 At the western end of the dyke was a sunken area [2] measuring 4m by 5m, which was associated with the entrance to a stone culvert (Plate 4). This culvert ran eastwards under the road to the river, and was fed by a modern open drain running down the west side of the field.

- 5.7 The entrance to a culvert was located at the southwest corner of the site. It is very likely that this is the 'tunnel' referred to by Curwen, which was built next to the bridge to take the overflow water in 1829.

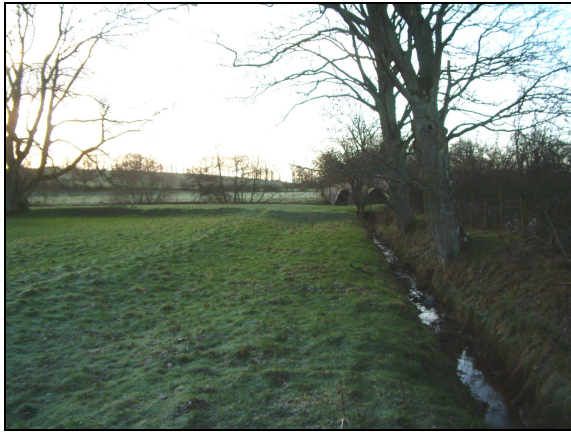
Plate 5. Bank of possible field boundary on the west side of the field, looking south

- 4.1.4 Parallel with the western boundary to Musgrave Church Field was a low straight bank measuring 64m long and 4m wide, aligned north-south [3]. Immediately west of this was a shallow sunken linear feature, measuring 82m long and 3m wide, and 0.3m deep. It is probable that these are the remnants of a former field boundary, illustrated on the 1st Edition Ordnance Survey map (Plate 5).

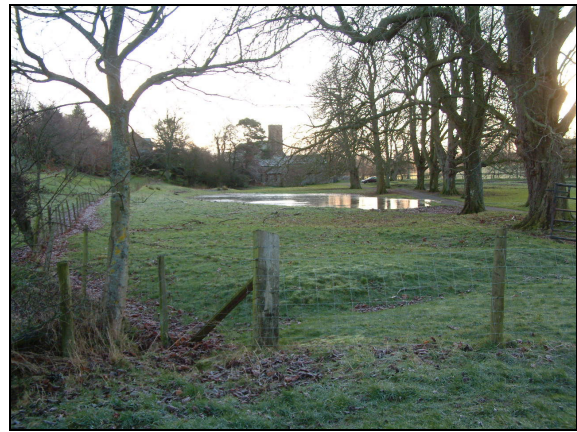
Plate 6. Short section of bank and ditch at the northwest corner of Musgrave Church Field, looking southeast

- 4.1.5 At the northwest corner of the field, on the north side of the drive, was a short straight section of ditch measuring 7m long, 2m wide and 0.3m deep [4]. This ditch was bounded on the east side by a short section of bank, which curved to the west and the south for a further 16m, being 3m wide and 0.2m high (Plate 6). This ditch and bank may also form part of a former field boundary, similar to that seen to the south of the drive. The curving section of bank may have resulted from the construction of the drive.

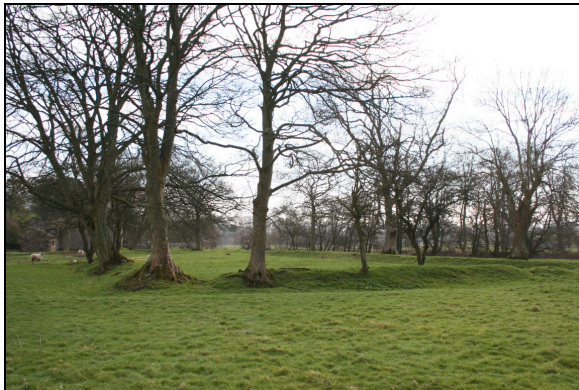
Plate 7. Banks and ditches enclosing the former gardens, looking southeast

- 4.1.6 Situated 100m to the east of St Theobald's Church was an earthen bank [5] measuring 3m wide and 0.5m high, with steeply sloping sides and a 0.5m-wide flat top. This bank ran roughly east to west for 152m, and turned south to run for a further 21m to meet the linear dyke. This feature enclosed a rectangular area measuring 0.3ha to the north of the dyke, which is identified on the 1840 plan as orchard and gardens (Plate 7).

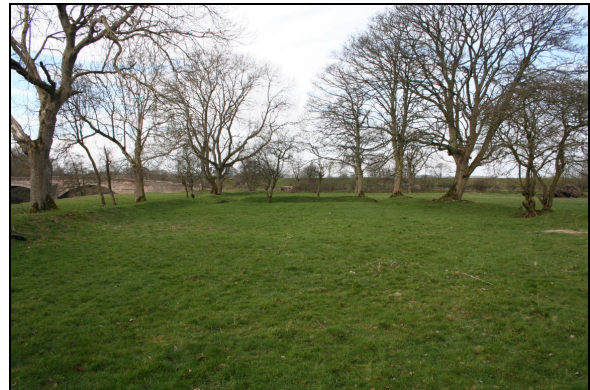
Plate 8. Interior of the former rectory gardens, looking east

- 4.1.8 Within the enclosed area a number of slight earthworks were visible (Plate 8). A central raised rectangular area on the east side measured 18m by 34m. This was separated from another raised area to the west by a 2.5m-wide shallow depression [7]. This depression marks the location of a former boundary feature, shown on the 2nd and 3rd Edition Ordnance Survey maps separating the former rectory orchard and gardens. The area to the west measured 27m by 15m, and contained two circular depressions on the south and west sides, interpreted as tree bowls [8]. These are probably the locations of former orchard trees.

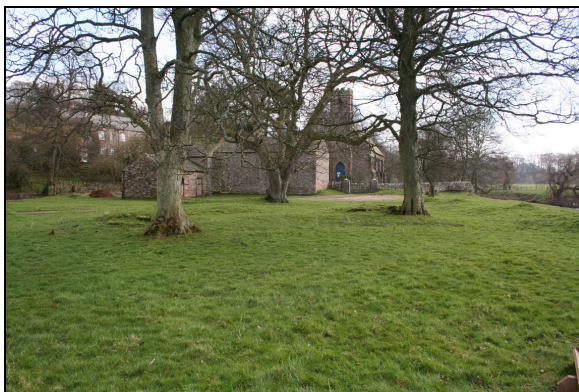
Plate 9. Site of the former rectory building looking east towards St Theobald's Church

- 4.1.11 To the east of these was another 10m-long section of curving earthen bank [13], aligned approximately east to west. This was 4.2m wide and 0.2m high on the south side, being 0.6m high on the north side where the ground level appeared to have been reduced. Together with the two similar sections of bank above, this bank formed part of an annex, enclosing the former rectory buildings, as shown on the 2nd Edition Ordnance Survey map of 1898. This enclosure has since been destroyed at the east end, although a remnant of this survives at the eastern tip of the earthen bank [13]. The original entrance to this enclosure was probably on the north side, between the two surviving sections of bank, measuring 6m wide (Plate 9).

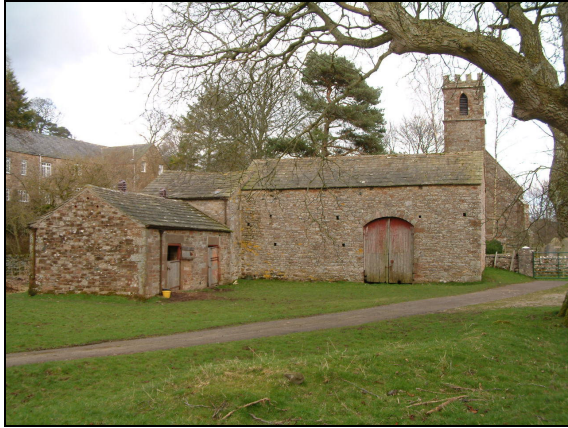
Plate 11. Post-medieval and modern buildings at the east side of Musgrave Church Field

- 4.1.14 Three post-medieval and modern agricultural sandstone buildings with pitched slate roofs were situated at the northeast corner of the site (Plate 11). The animal shed and barn appeared to be 18th century, but earlier foundations were visible beneath these buildings. The stable had a datestone above the south door, which stated that the building was constructed in 1937 by the Rev. Keith Fraser. The southern stable wall contained a number of pieces of dressed and decorated red sandstone, which could have come from the former rectory building (Plate 12).

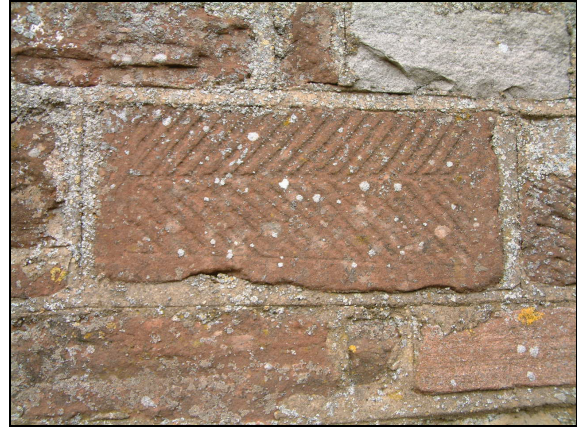
Plate 10. Reused decorated sandstone in the south wall of the modern stable building

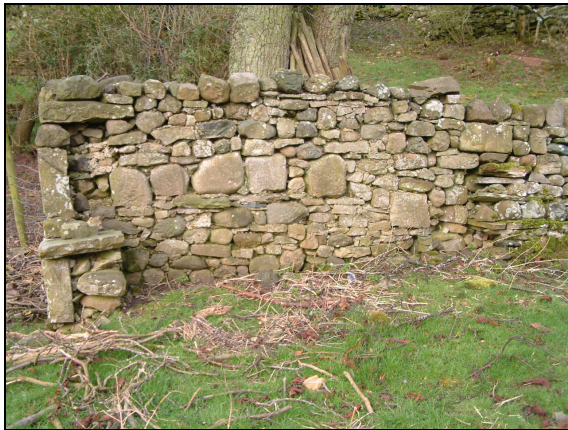
Plate 12. North wall of a former shed contained within the northern site boundary wall, looking north

4.1.15 To the north of these buildings was a section of stone building, comprising the end wall of a 3m-wide shed, incorporated into the stone wall (Plate 13). The foundation stones of a stone wall were also visible in the northeast corner. This is shown as a stone wall on the 2nd and 3rd Edition Ordnance Survey maps.

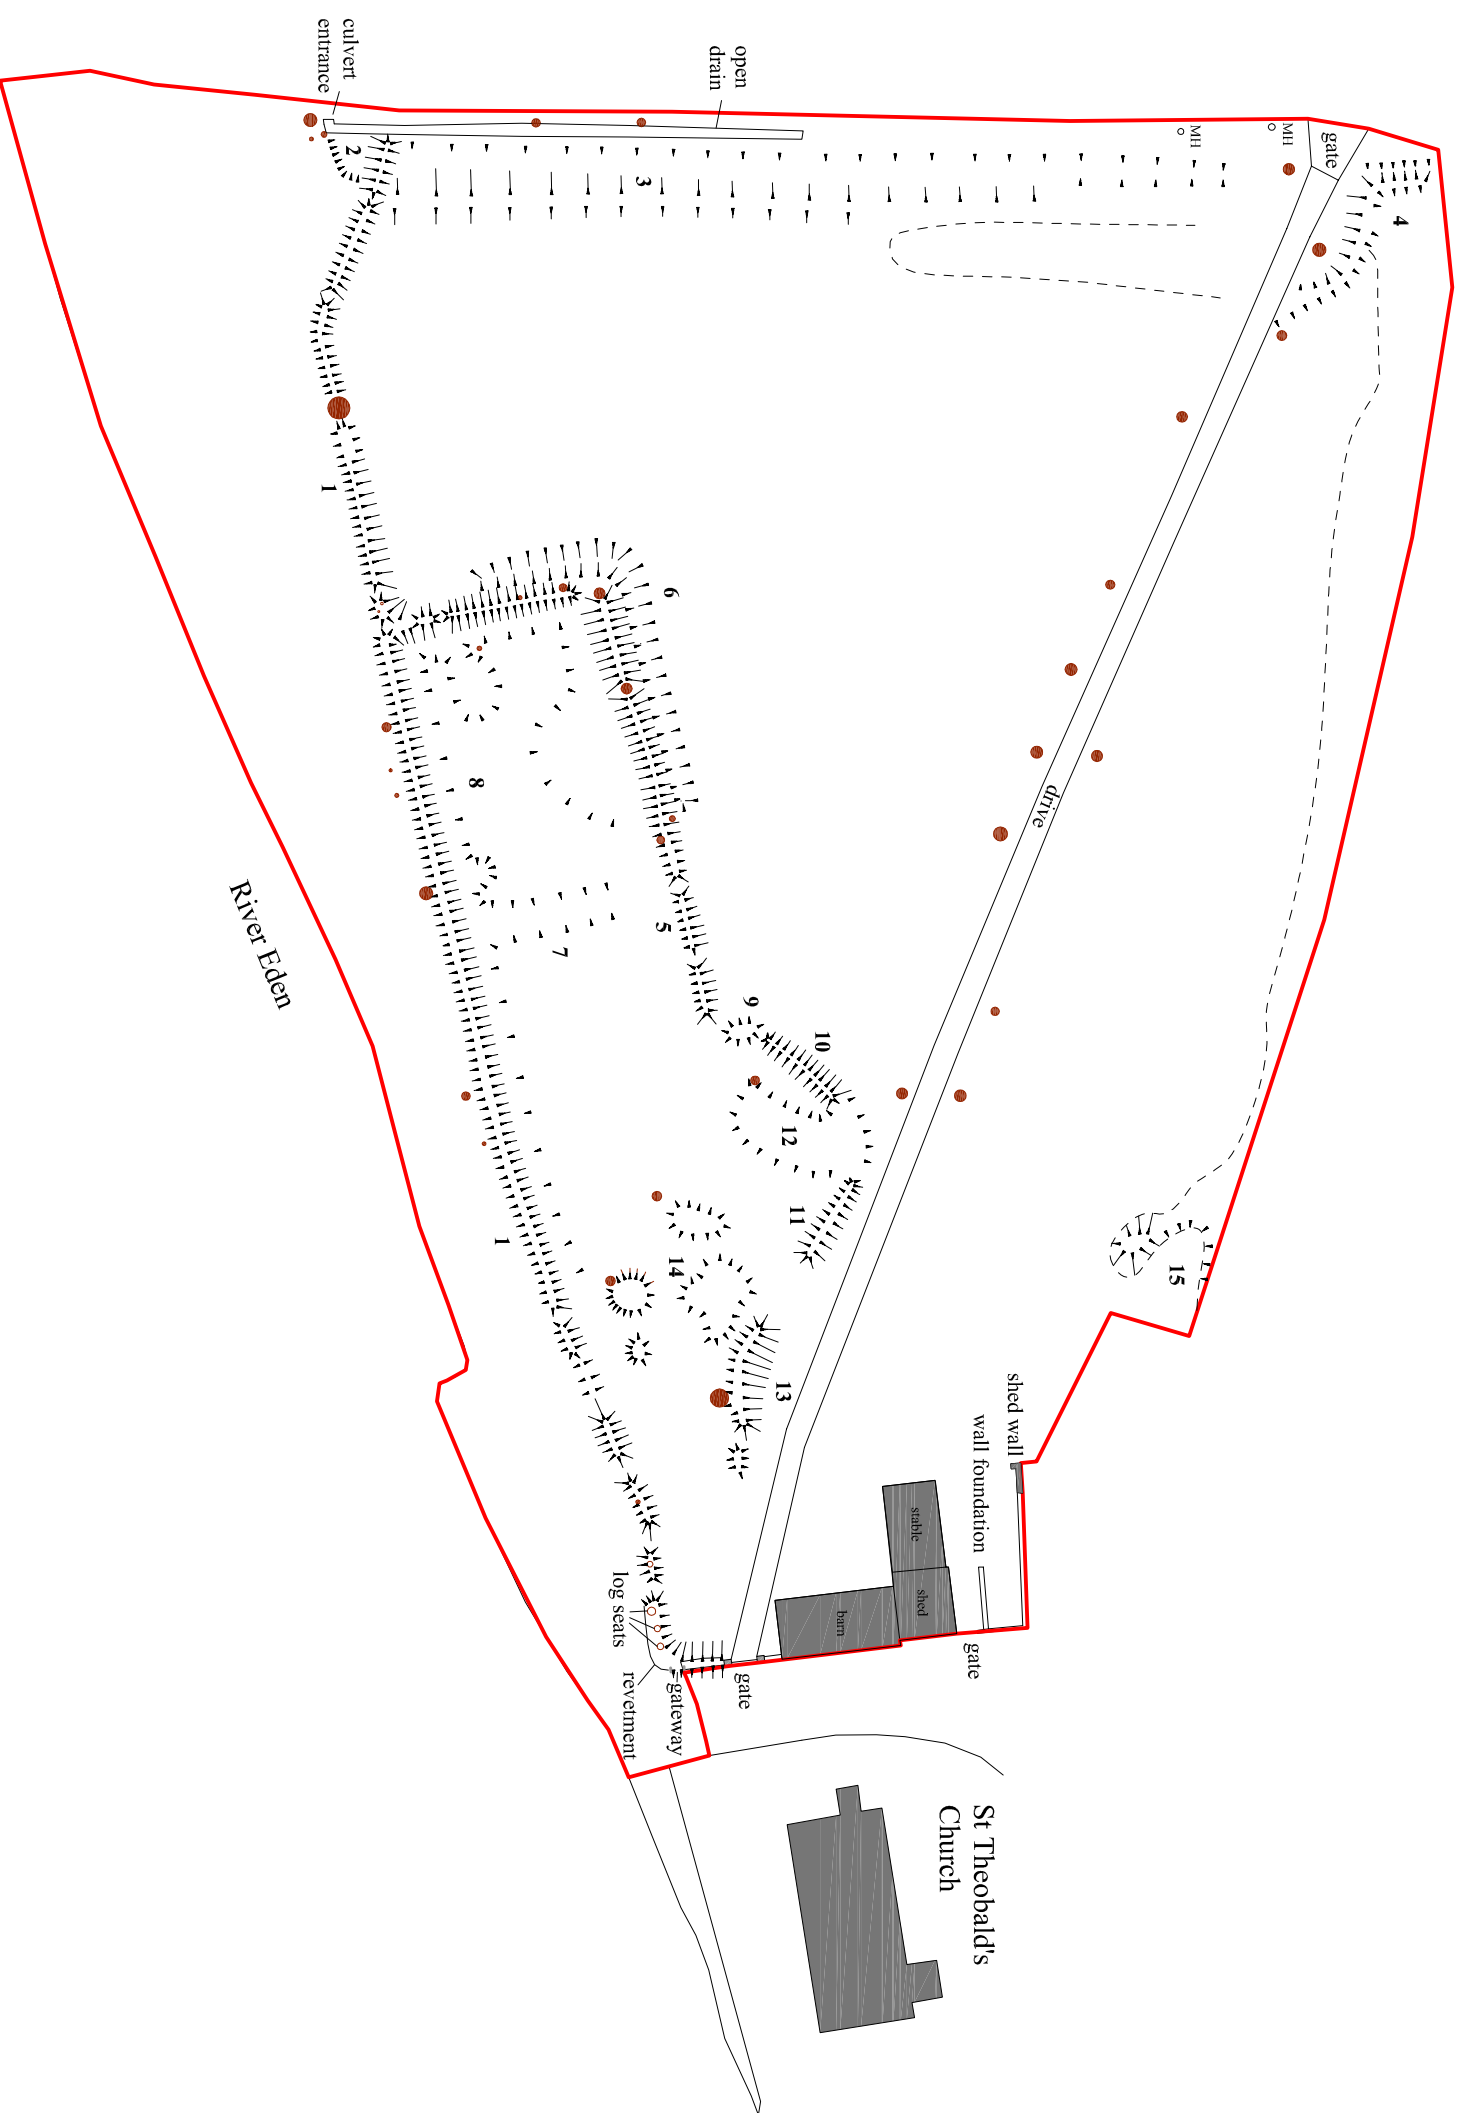
Figure No: 7

- 4.1.1 The earthwork survey was undertaken between 6th and 8th March 2007, and included all visible earthworks and structural remains contained within Musgrave Church Field. At the time of the survey an area north of the drive was permanently flooded. However no earthworks were believed to be present in this area. A written description of the earthworks is included below. The numbers in square brackets refer to the earthworks as depicted in the hachured plan (Figure 7).

Figure 7 : Earthwork plan of Musgrave Church Field
