Wembury Mill – an illustrated history

David Pinder*

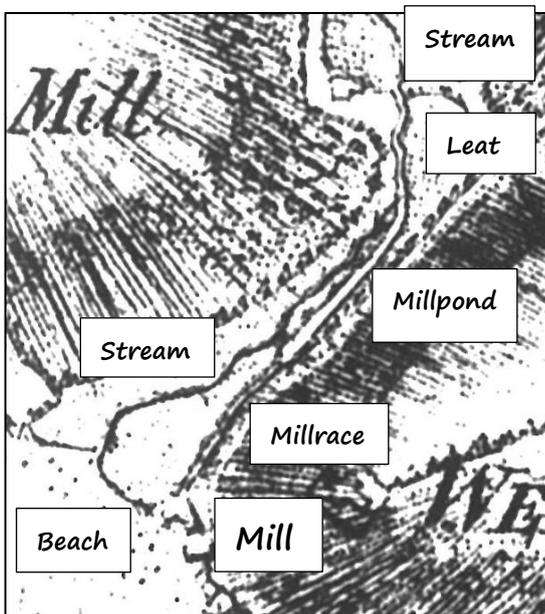
Figure 3 Key components of the mill's water supply system

Building the mill into the cliff set the scene for this advantage to be exploited, but also necessitated investment in a water supply system able to drive the water wheel from above. The existence of this has been almost completely forgotten, but an Ordnance Survey map for which the survey was done in the mid-1790s (Figure 3) clearly reveals the approach adopted.³

The stream which fed the system still runs through Mill Meadow. Entering the meadow from the north at about 14 m above sea level, it fed a short, curving leat which channelled much of the water along the valley's eastern slope, maintaining most of its height. This leat fed the system's central element: a long narrow millpond, excavated into the valley side and running below the road leading to the beach. Then a mill race – essentially another leat – delivered the stored water from the pond to the mill, which it reached at around 8 or 9 m above sea level. Today the remains of the race at this point can easily be seen from the wall behind the mill: the stone-lined channel turns a right angle, beyond which there was a wooden launder to direct the water onto the wheel (Figure 4). Adopting this three-part solution to powering the mill was in no sense innovative, but it was tried, tested and reliable.

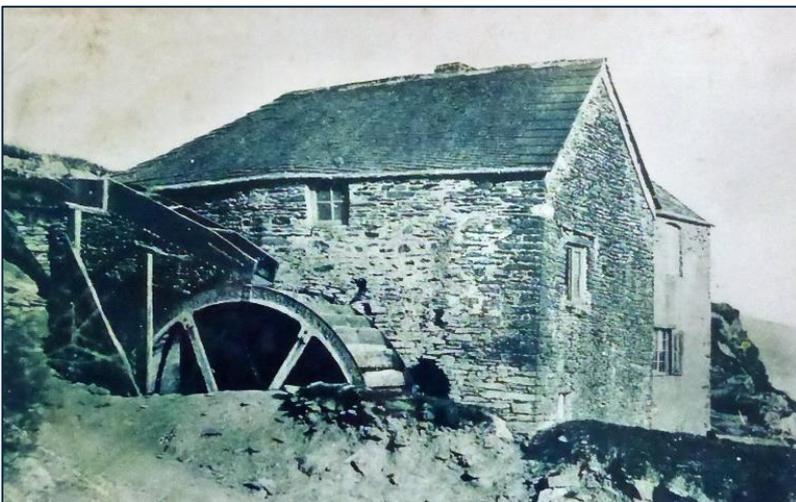
Figure 4 The mill wheel and launder

Those who originally chose the mill's site would not have shared today's heritage perspective; their decision making would have been extremely practical, not least with respect to efficiency. Although it would have been perfectly possible to locate the mill by the nearby stream, this would have imposed a major handicap. In that position it would have been an undershot mill, its wheel being driven by the flow of water at the base, a system which is usually less than 25 per cent efficient. In contrast, overshot mills – whose drive water is delivered from behind and above the waterwheel – harness the gravitational power of the falling water, which can double or even triple efficiency.²

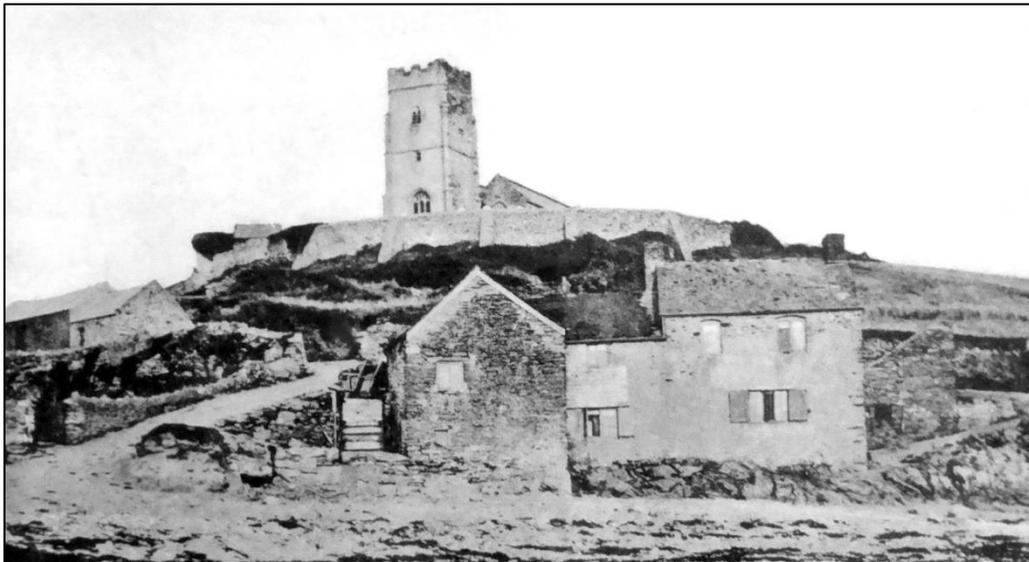
Figure 5 Building age differences

Exactly when Wembury Mill's monopoly came about is not the only unknown. Another is the construction date of the mill buildings we know today. What is clear, however, is that these buildings do not all date from the same era (Figure 5). The style of the miller's house, on the right, is consistent with an early to mid-nineteenth century date.⁵ In contrast, the remaining buildings – the

mill on the left, plus a surviving part of what was probably an earlier miller's cottage – are clearly significantly older. How did this contrast arise? The explanation *may* lie with a major event long since forgotten.

Given the severity of the damage, it could well be that the juxtaposition of the old and the relatively new revealed by Figure 5 was a consequence of the response to this major setback. Restarting the mill's production would no doubt have been seen as the priority - hence a decision to repair the existing structure rather than build anew. Conversely, dealing with the badly damaged house could easily have been considered less urgent – the family could have temporarily moved elsewhere – allowing time for most of the damaged cottage to be replaced by a house no doubt better than anything experienced by previous mill tenants.

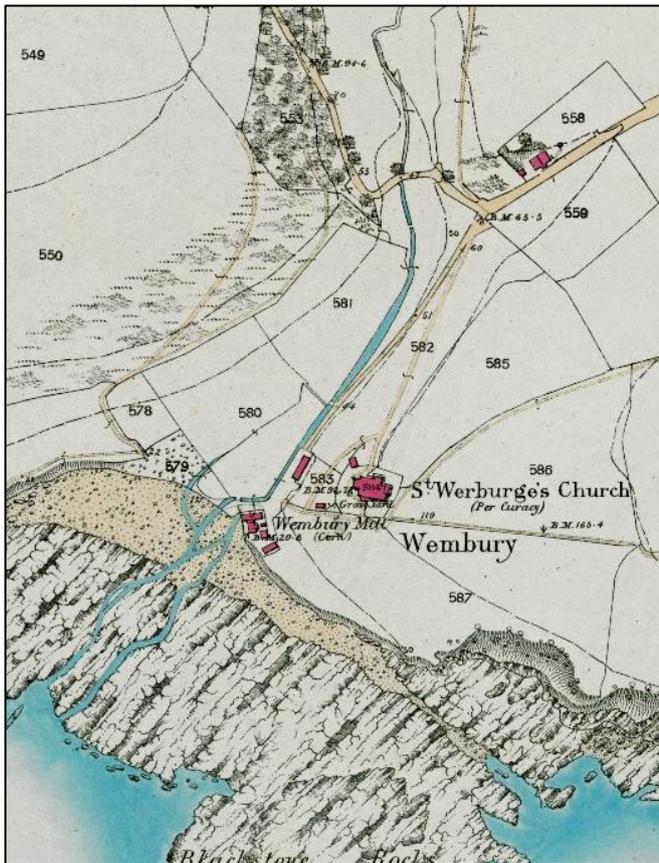
Figure 6 The mill's modified water supply system c. 1850

Another significant development in the first half of the nineteenth century was an extensive remodelling of the mill's water-supply system (Figure 6).⁷ At the northern end of Mill Meadow the entire stream was now diverted into the leat, leaving the natural watercourse dry. From there the water was channelled straight through the millpond section before running on towards the mill via the existing mill race. Just before the mill a control system, probably involving sluice gates, was installed to direct the constantly flowing water either to the mill during working periods or, at other times, down a spillway to the beach (Figure 7). Embarking on this overhaul may have been a response to millpond deterioration, such as silting or the encroachment of vegetation, after a long working life. But it is also likely that there were advantages. In particular, milling no longer had to stop because the millpond was empty and, as the entire stream was harnessed, more power was available. As with other twists and turns in this story, precisely when the revamp was undertaken is unknown, but the survey dates of OS maps indicate a timeframe of between 1800 and the early 1850s. Within this span, however, the work *may* have been linked with the mill's repair following the 1824 storm. An ideal time to undertake the work in Mill Meadow would have been while the

7 Figure 6 is an extract from the Devon Sheet C.XXX.6 of the Ordnance Survey's 25-inch map of this part of Wembury . It is reproduced under the OS's fifty-year rule. The fact that it is coloured indicates that it was one of the earliest to be produced and was probably surveyed no later than the mid-1850s. The National Library of Scotland (NLS) has a substantial collection of these maps, which were produced in a series of editions up to 1956. Scans of specific sheets can be purchased online from the NLS.

8 Digital copies of both the prospectus and its accompanying map are available from WLHS. Contact via the WLHS website. Among many other things, the map shows the mill's restructured water-supply system, as detailed in Figure 6.

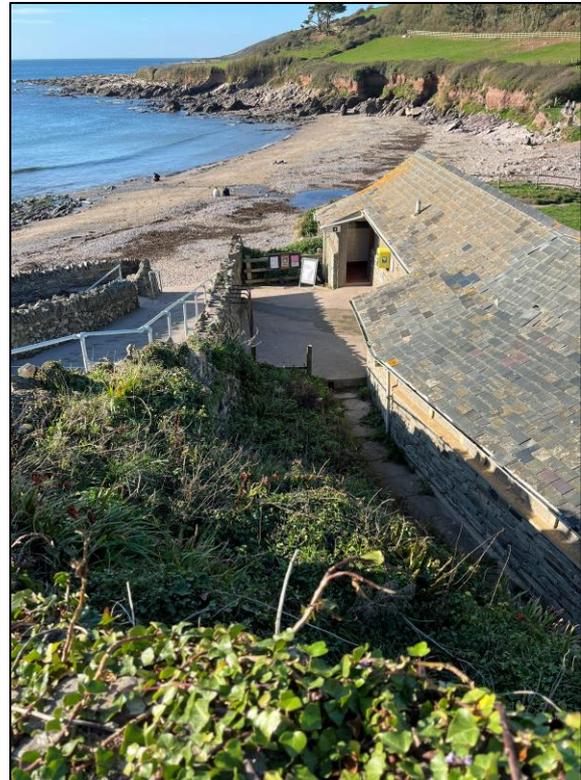
Figure 7 The line of the modified system's former spillway. Today, the public toilets are on the right and the steps on the left.

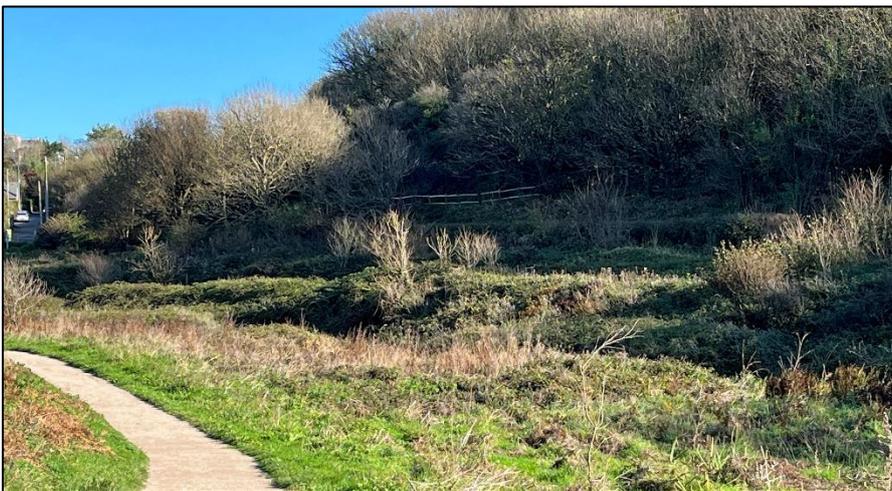
Figure 12 The western millpond embankment. Today's stream occupies the ditch between the embankment and the path.

Despite these obstacles, three sources suggest that all may not be lost. The National Trust surveyor's report in 1984 noted earthworks in Mill Meadow that were consistent with the remains of the mill's water-power system. Today, Google Earth images strongly suggest the outlines of the millpond, picked out by contrasting vegetation shades. And, remarkably, with a magnifying glass it is possible to see the unmistakable outline of a millpond on today's OS 1:25,000 map.¹⁹

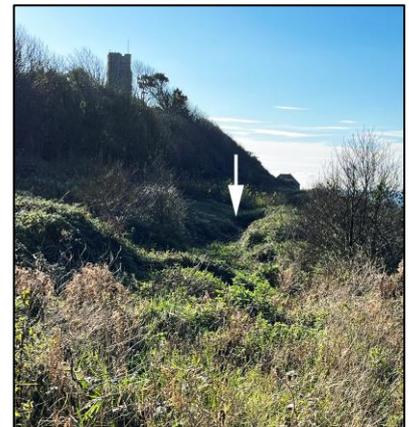
Figure 13 Remains of the leat leading to the millpond

Against this background, it is no great surprise that significant remains can indeed be identified in Mill Meadow. Towards its northern end, and east of the stream, there are two lengthy, almost parallel, earthworks on a roughly north-south axis. Of the two, the one closest to the stream is particularly prominent and can easily be viewed from both the footpath through the meadow and the path running above the road leading to the beach (Figure 12). These features are clearly the remains of the embankments which enclosed the millpond. Moreover, vegetation clearance at the very northern end of the meadow early in 2024 opened up a view revealing part of the leat's route into the pond (Figure 13).

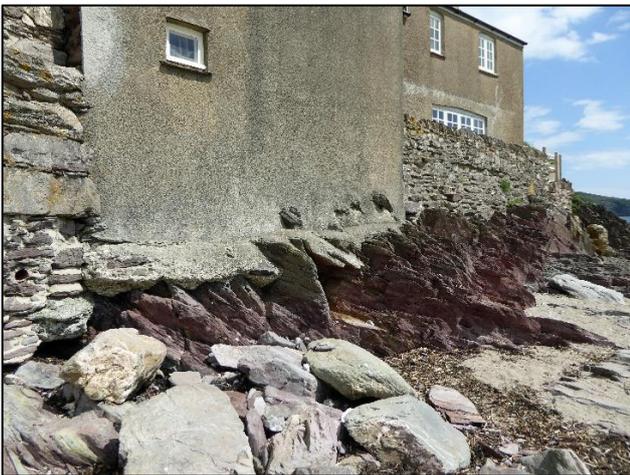
Figure 14 Erosion of the rock platform on which the mill is built

Although the supply system has lain largely forgotten, the resurrection of first the mill and then the miller's house can now be seen as a successful heritage conservation story. But this does not mean that their long-term future is secure. In recent years the local impact of climate change has become ever clearer. The front wall of the house has already needed extensive repairs. On at least two occasions there has been serious erosion of the rock platform on which the buildings stand; one of these events came very close to undermining a corner of the house. A nearby wall originally built to support the miller's vegetable garden has been badly damaged twice, part of a wider process of active erosion now affecting the low cliffs west of the mill. As the earlier discussion has underlined, storm damage is nothing new - many batterings have been survived. Yet now the strong probability is that, even if storms do not become more frequent, their intensity will greatly increase.

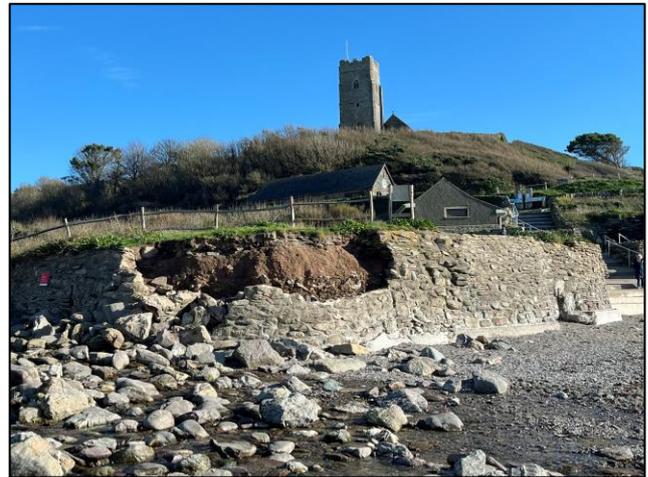
Figure 15 Wall collapse, 2024
