Neighbourhood Development Order North Benfleet

HERITAGE AND ARCHAEOLOGY ASSESSMENT

December 2023 Regulation 21 version

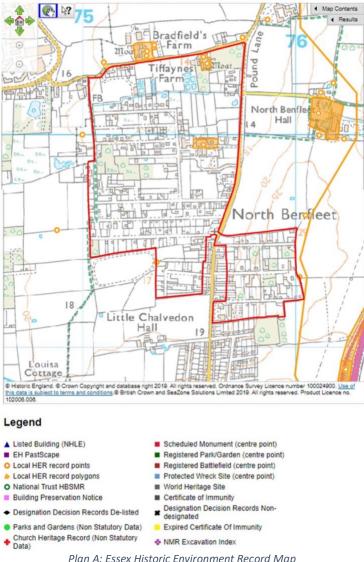
Plan A: Essex Historic Environment Record Map

The Essex Historic Environment Record (HER) has been reviewed and Plan A shows the location of findings, structures and artefacts in addition to listed buildings within close proximity to the area covered by the NDO ('the site').

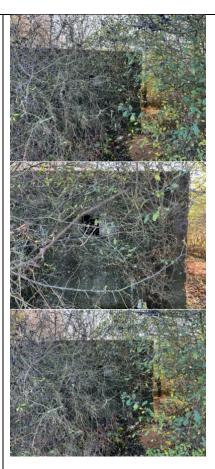
At the edge of a field W of Pound Lane is an FW3/24 thin-walled pillbox. It is constructed of brick and concrete although, unusually, it was originally shuttered with wood on the outside and brick on the inside. The walls are 18 inches thick and the pillbox faces NE. Inside, there is a central Y-shaped pillar. <1>

There is no evidence that any part of all but one (pictured) of these assets remains on site. Some pillboxes are protected through scheduling and listing due to their rarity, level of preservation and historical significance. Otherwise, the historic interest of pillboxes is limited to the preservation of surviving wartime sites. It is considered that the FW3/24 pillbox design was the most common built during 1940 and 1941. The pillbox at the edge of a field west of Pound Lane remains on site. Its significance is therefore of
